- Single Span prestressed concrete adjacent box beams on abutments on piles
- Span: 34'
- Roadway 48 f/f guardrail
- Built 1986
- Center two beams to be replaced in 2017

- Single Span prestressed concrete adjacent box beams on abutments on piles
- Span: 33'
- Roadway 50 f/f guardrail
- Built 1963
- Emergency Replacement Scheduled for 2017

- Single Span composite deck
- Span: 25'
- Roadway 32 f/f guardrail
- Built 2000
- Asphalt keeps sliding on the composite deck
- Have this problem on all our composite deck bridges

- Single Span prestressed concrete box beam bridge
- Span: 38'
- Roadway 24 f/f guardrail
- Built 1963

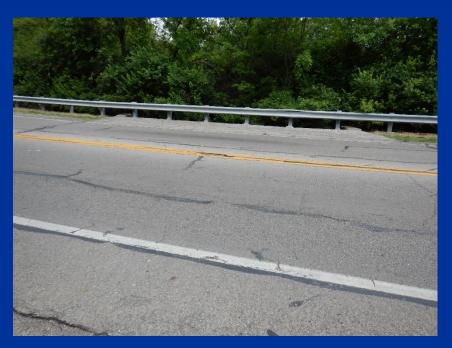
No evident problem visible from above

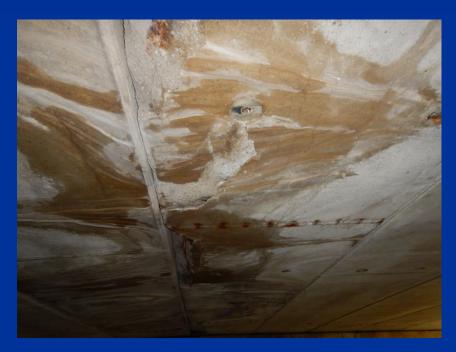
Underside of beams stained and delaminated

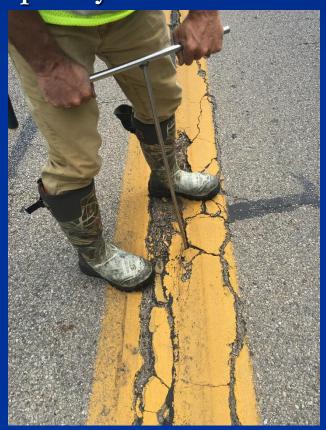
Finding no evidence of grout in center joint; can stick hand completely in it.

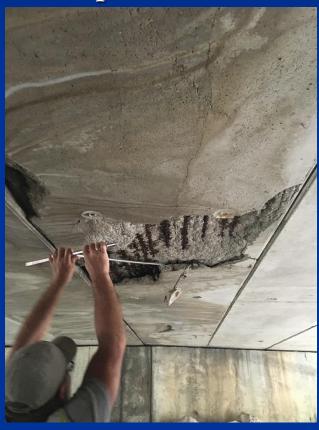
Investigating center beam; Completely delaminated and all strands exposed and/or broken.

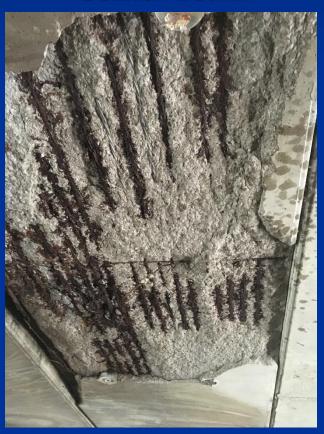
Center beam

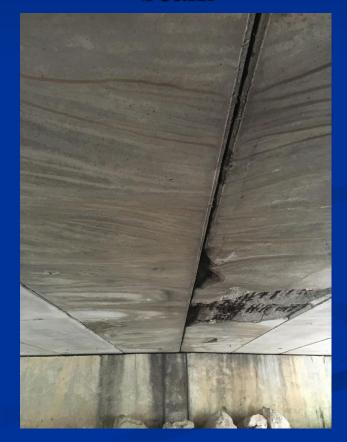
Staining on other center beam

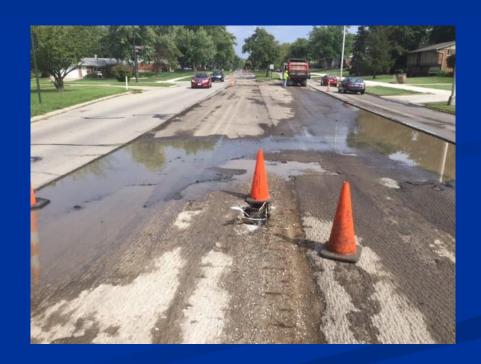
- City of Kettering milled road for resurfacing project
- Got call about hole in the bridge from city
- Beams were milled into during this milling process
- Appears beams were milled into on previous mill/fill project as well and not rewaterproofed

Stirrups visible

Top of box beams completely gravel

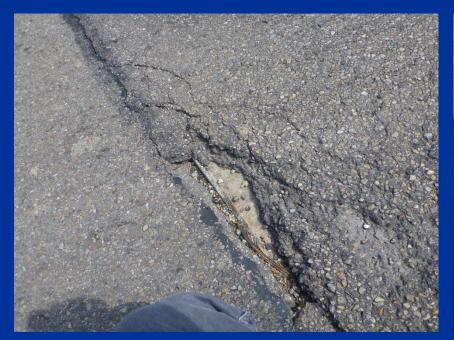
Deck exposed

Asphalt sliding

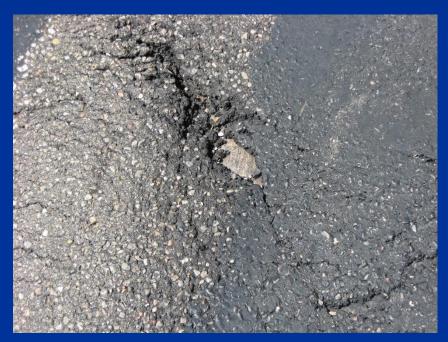
Asphalt sliding

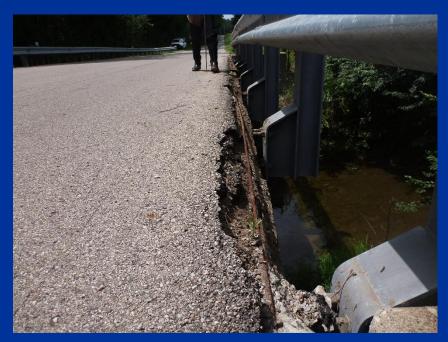
Failed Drip Edge
