BUTLER COUNTY ENGINEERS OFFICE

BUTLER COUNTY BRIDGE MANAGEMENT SYSTEM County Bridge Name: BRIDGE INSPECTION RECORD DEPOT ROAD - 0.114 ELEVATION LOOKING NORTH ENDVIEW LOOKING WEST. Structure File Number: 0931713 Inspected By: BRIAN D. DIETRICH General Appraisal Operating Status: 5 A Sufficiency Rating: 63.4 Inspection Date: 0.7 / 2.3 / 1.0 Inspection No: 2010 Townshin: STRUCTURE INFO NO. OF SPANS: O.A. LENGTH: 15 FT. DECK WIDTH: 17.9 FT. YEAR BUILT / REHAB: 1915 STRUCTURE TYPE: CONCRETE SLAB ON STONE MASONRY ABUTMENTS INSPECTION FINDINGS SPALLING WITH EXPOSED REBAR IN THE SPASCIA & SEND OF THE PLOOR. SECTION LOSS TO THE REBAR. DECK COMMENT: SUPERSTRUCTURE COMMENT: SPALLING WITH EXPOSED REBAR IN THE S FASCIA & 5 END OF THE FLOOR. SECTION LOSS TO THE REBAIL VERTICAL CRACK IN THE SOUTH CORNER OF THE WEST ABUTMENT, SPAILING OF THE WINOWALLS. SUBSTRUCTURE COMMENT: CULVERT COMMENT: SCOUR COMMENT: SCOOR ALONG THE WEST ABOTMENT CHANNEL COMMENT: CHANNEL FLOWS 99 DECREES TO THE DRIDGE CAUSING SCOOR. APPROACH COMMENT: RECOMMENDED MAINTENANCE COMPONENT PRIORFYY CONCRETE M CLEAN & PAINT THE EXPOSED REBAR WITH CORROSION INHIBITOR; PATCH SPALLS IN THE SOUTH PASCIA AND THE SOUTH FIND STEEL GUARDRA

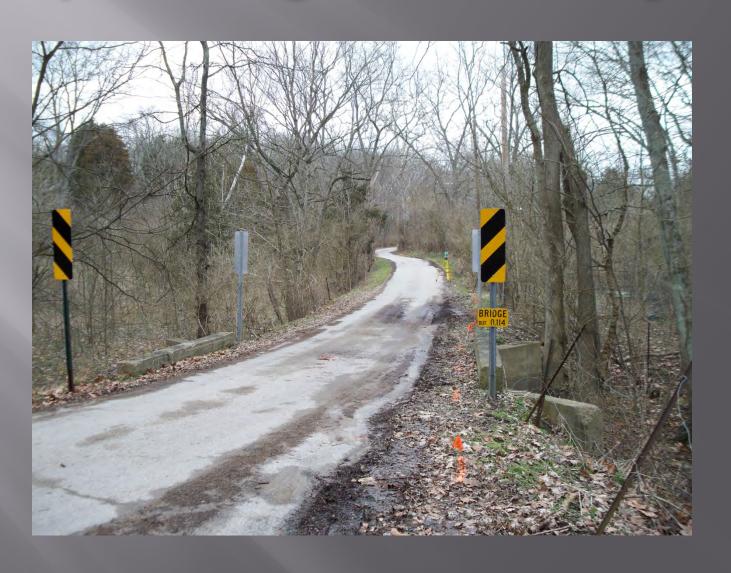
■ 2010 rated 5A

- Spalling with exposed rebar facia and deck
- Vertical crack in abutment
- Scour along west abutment

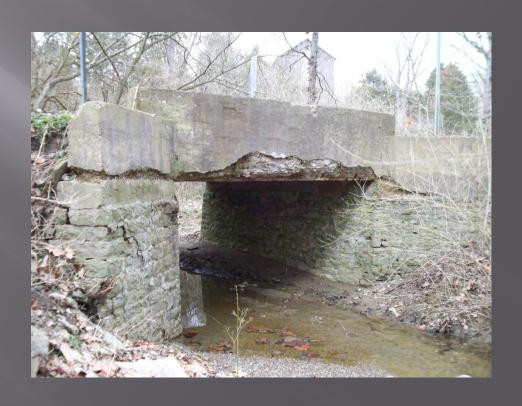
■ 2012 rated 4A

- Spalling with more exposed rebar
- More cracking in the stone abutments

Recommended for replacement
