**For additional information concerning the  
Marion County Engineer's Office please  
visit:**

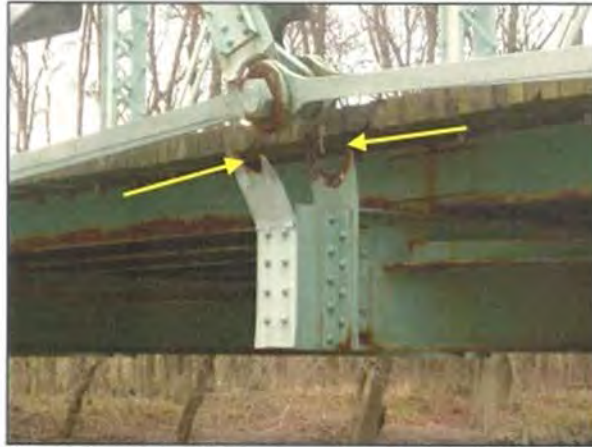
Photo 2—Panel Point L1', Downstream Truss. Note tensile failure of floorbeam hanger plates.

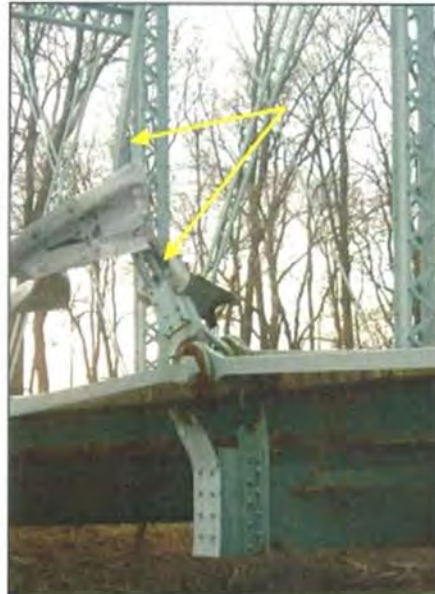
Photo 3—Panel Point L1',  
Downstream Truss. Note  
severe deformation of  
vertical member L1'-U1'.
