# Bridge Rehabilitation and Cost Effective Methods for Addressing Bridge Deterioration

**Presented at**  
**Ohio County Engineers Conference**

**August 23, 2017**

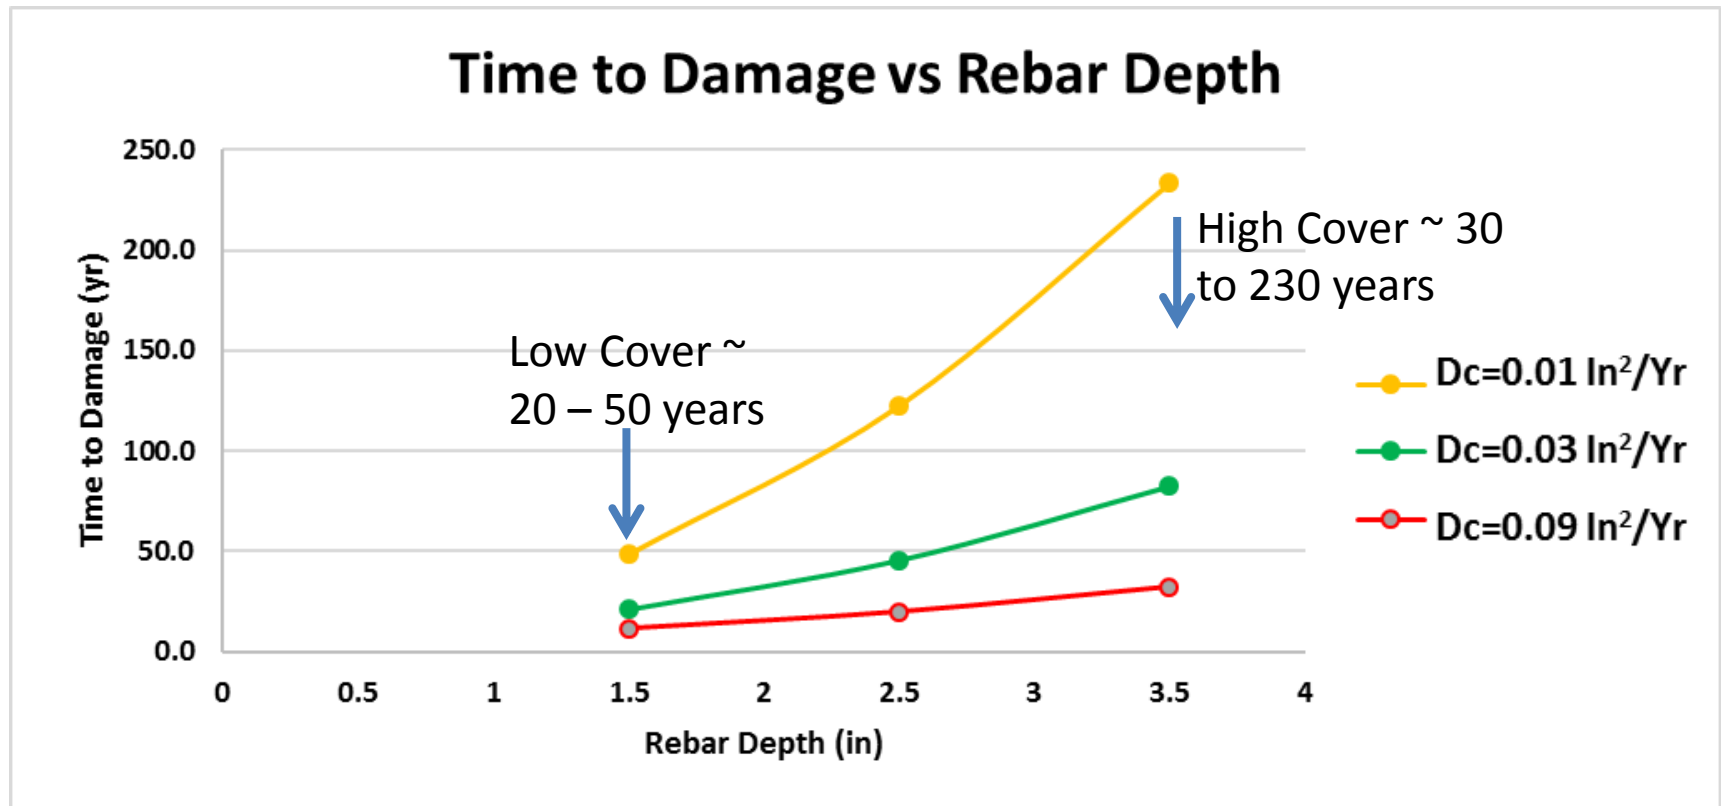
# Time to Concrete Damage for Various Rebar Depth

- **Using**
  - Cover of 1.5", 2.5", and 3.5"
  - Average surface chloride for deck, substructure, and piles in marine environments
  - Chloride at the rebar = 400 ppm
  - Diffusion coefficients (in<sup>2</sup>/yr.) of:
    - ✓ 0.01 in<sup>2</sup>/yr. – Excellent durability,
    - ✓ 0.03 in<sup>2</sup>/yr. – Good to fair durability,
    - ✓ 0.09 in<sup>2</sup>/yr. – Poor Durability

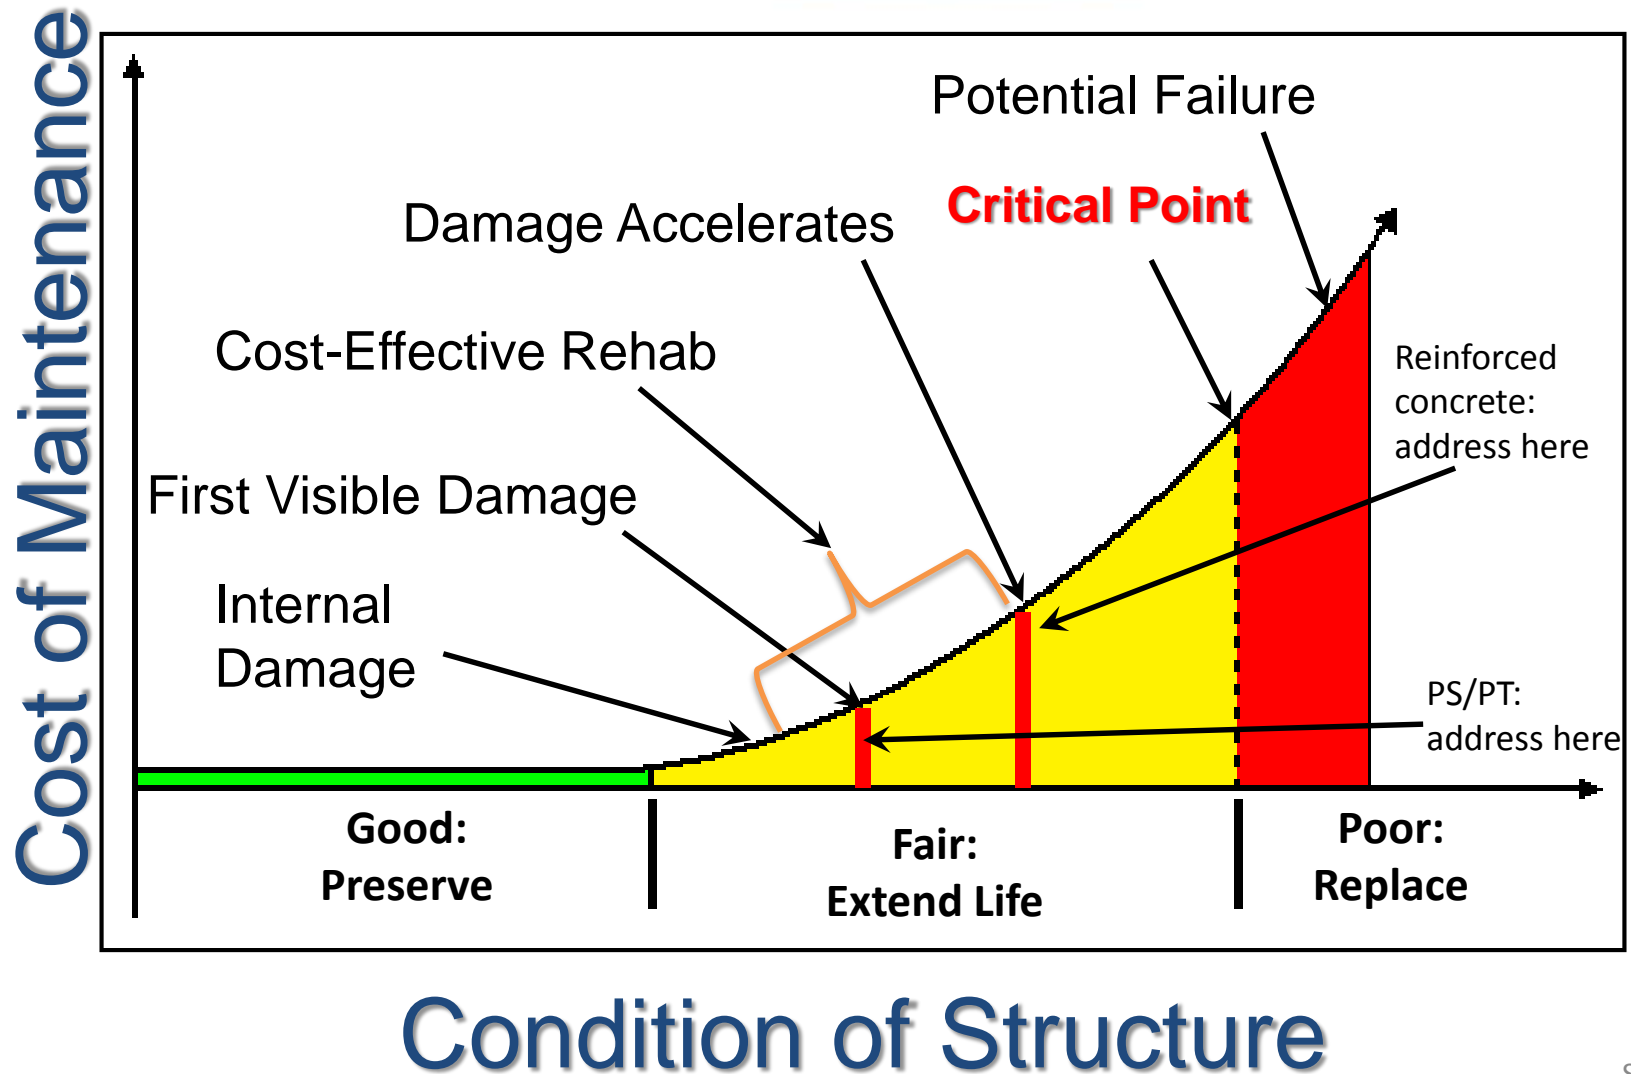
# Corrosion-Related Concrete Damage

- Chloride from deicing salt application diffuses into concrete
- When chloride at rebar level exceeds 1.2 lb/CY, passive film breaks down and corrosion initiates
- If  $\text{pH} < 11$ , corrosion can initiate at lower chloride levels
- If sulfate is present, chloride may not be required for corrosion to begin

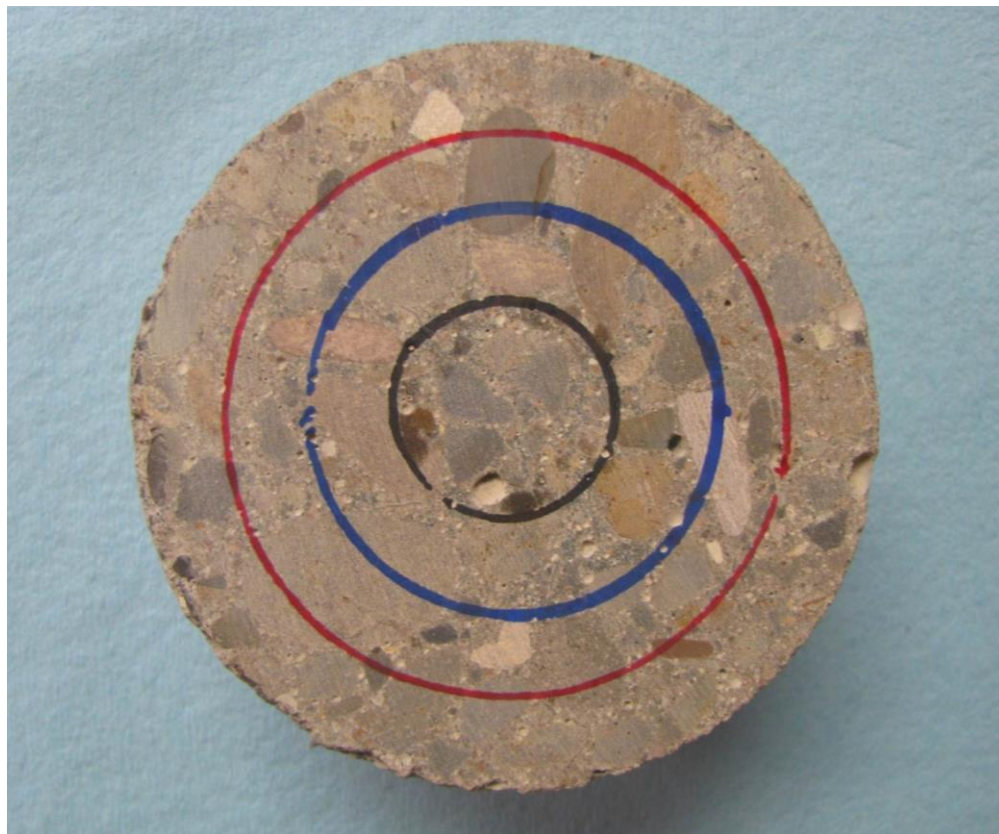
- Chloride cores shall be 4-inch diameter, at least 3-inch diameter.
- A smaller core or powder samples can lead to significant variation in chloride level leading to erroneous decisions.
- Sampling number – sufficient to represent the entire structure.

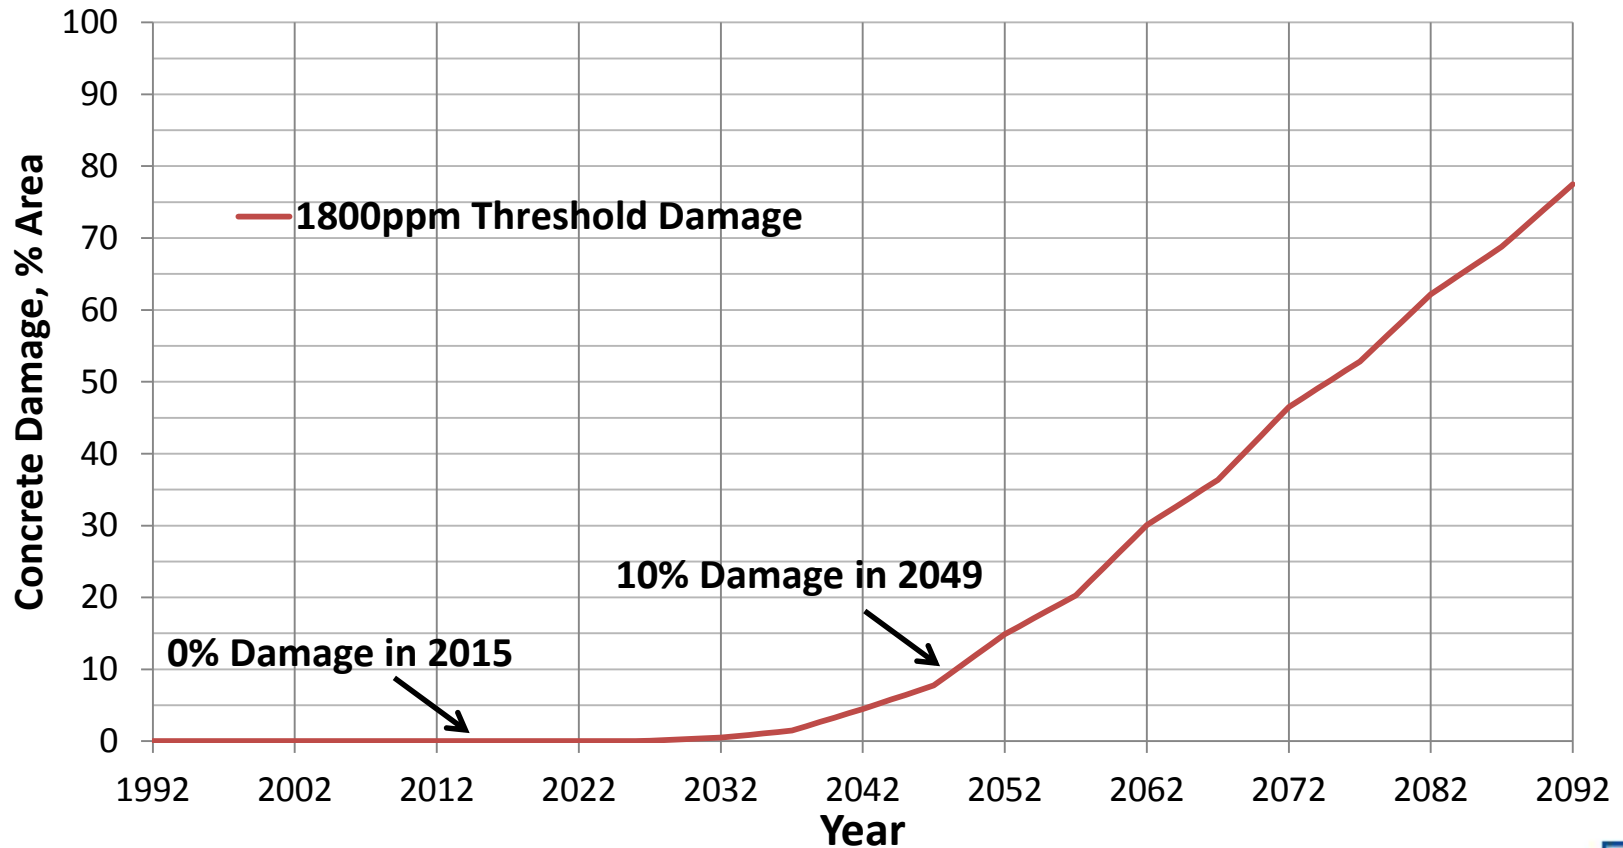
**Projected Concrete Damage of Deck - 36511**

# Service Life Model (Future Damage): Example 1 – Bridge 36511- Cl @ threshold

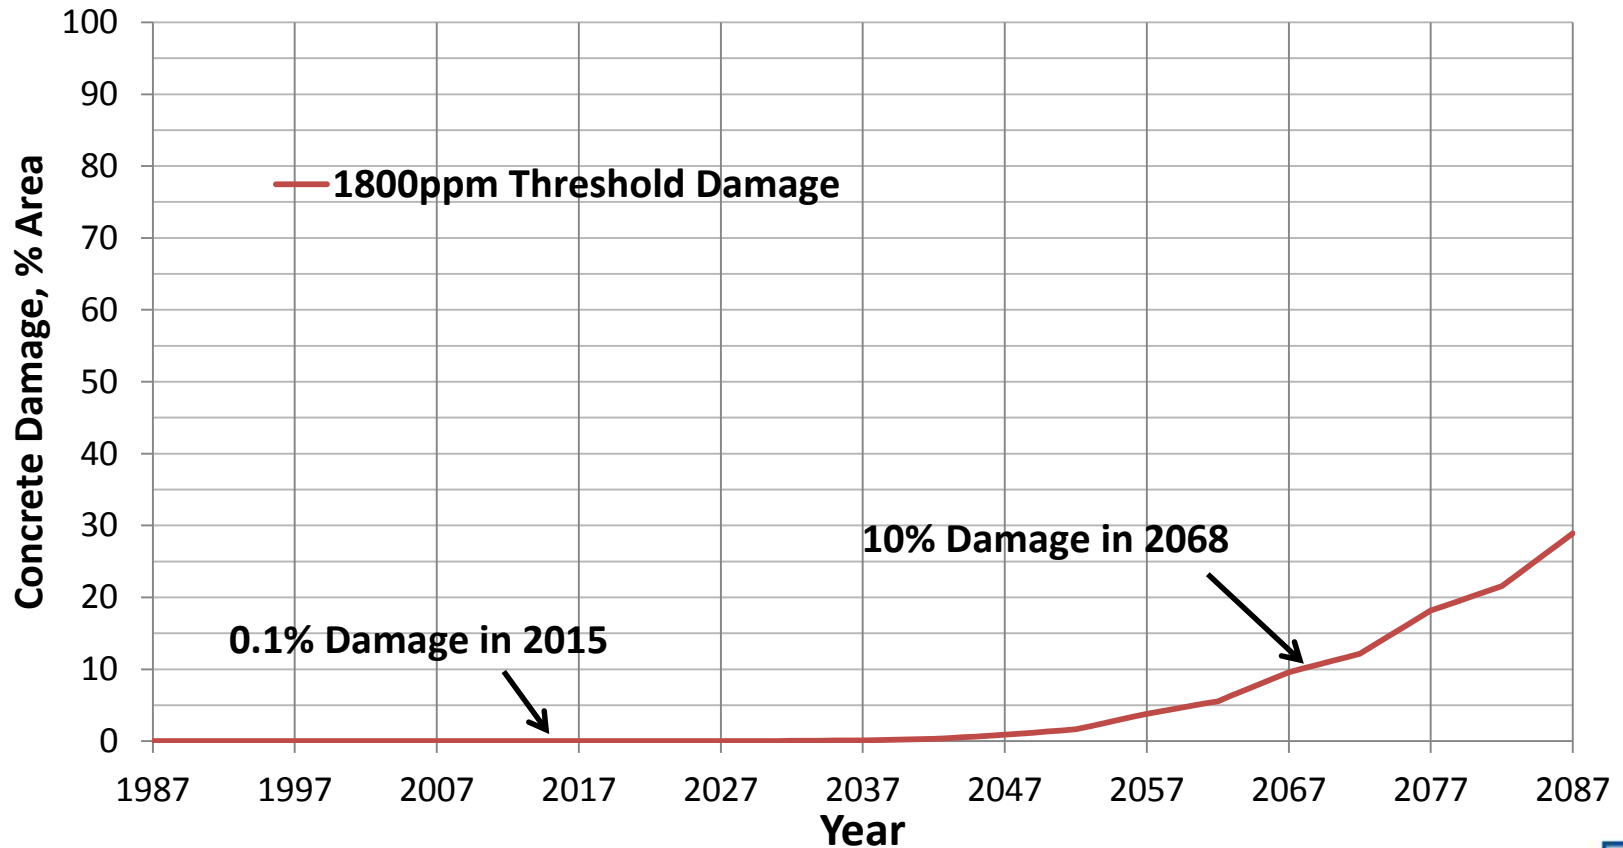
**Projected Concrete Damage of Deck - 20291**

# Service Life Model (Future Damage): Example 2 – Bridge 20291-CI below Threshold

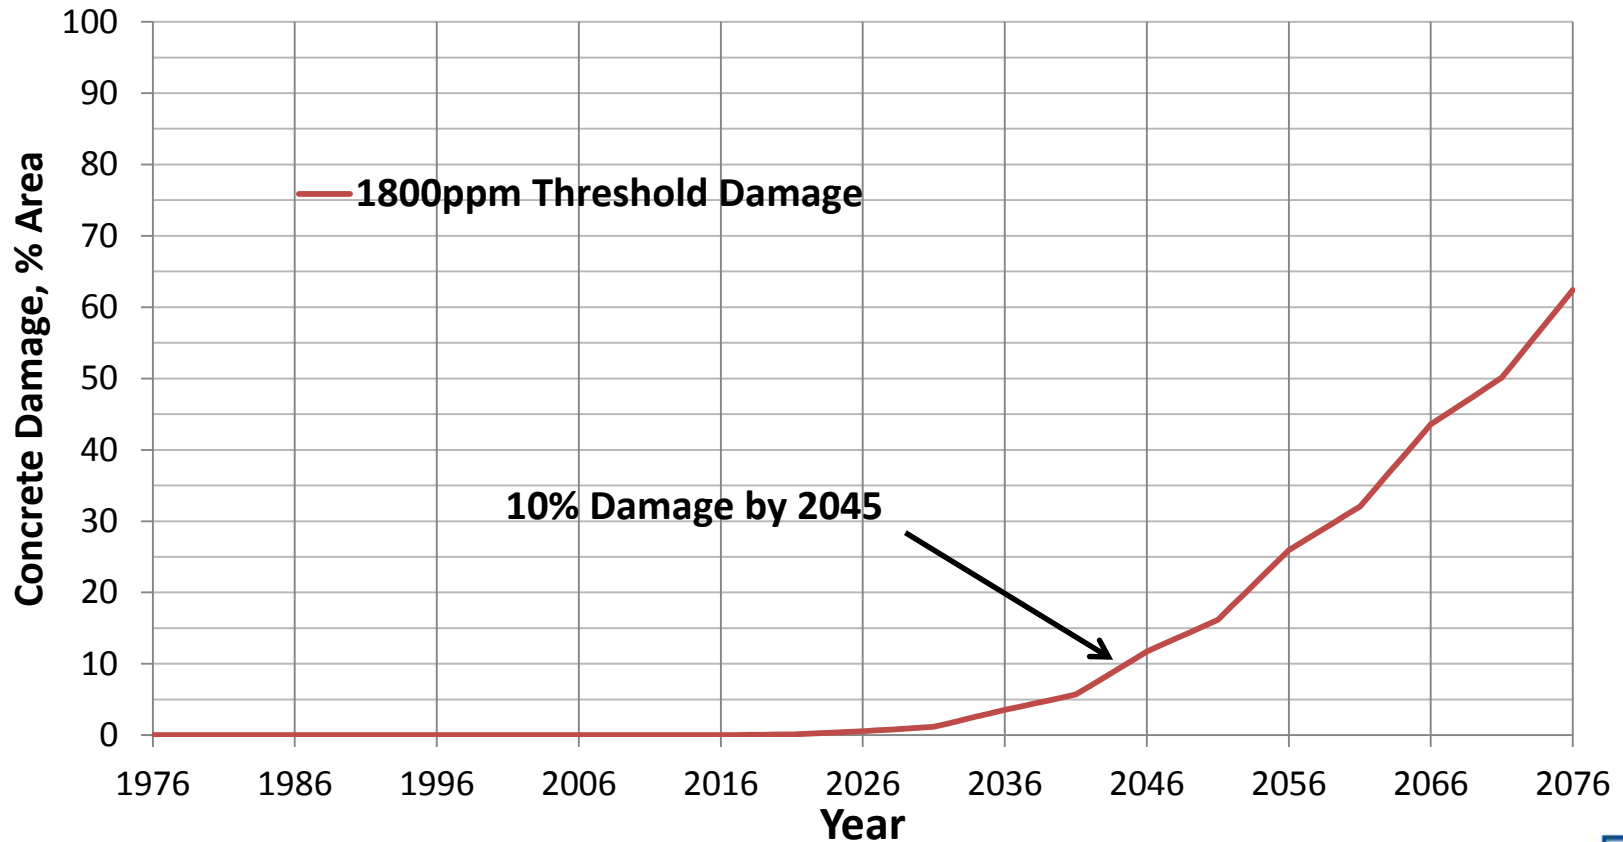
**Projected Concrete Damage of Deck - 28731**

# Service Life Model (Future Damage): Example 3 – Bridge 28731-CI above Threshold

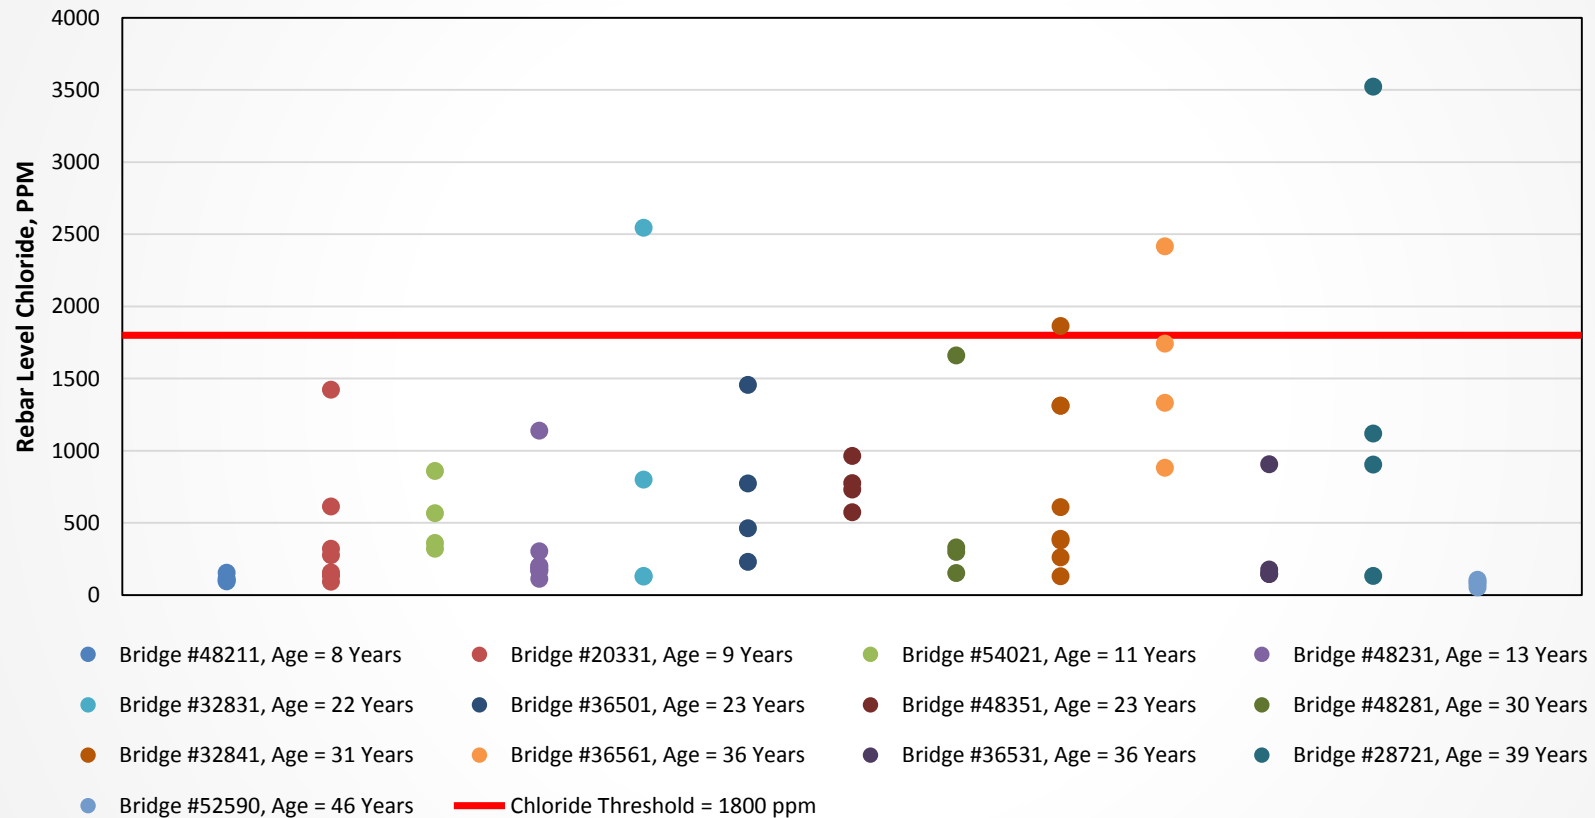
All Non-Service Life Bridges

# Non-SLB Chloride Analysis

- 1800 ppm chloride threshold for epoxy-coated rebar decks
- Using 50% of chloride threshold, time to 900 ppm =  $900/33.624 \approx 25$  years
- SCS suggest collecting cores and testing for chloride profile at 25 years of age

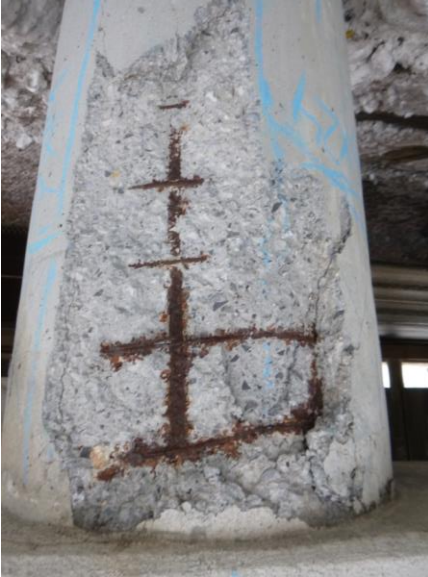
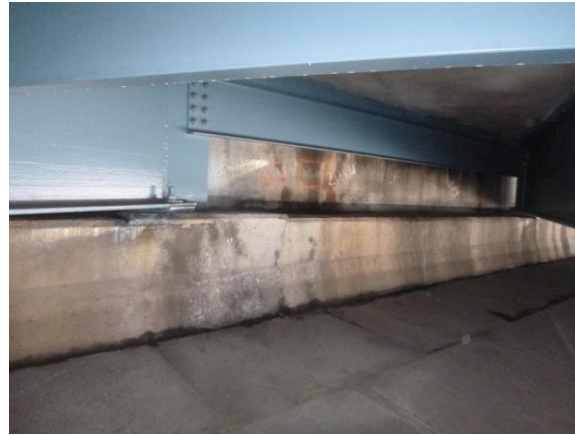
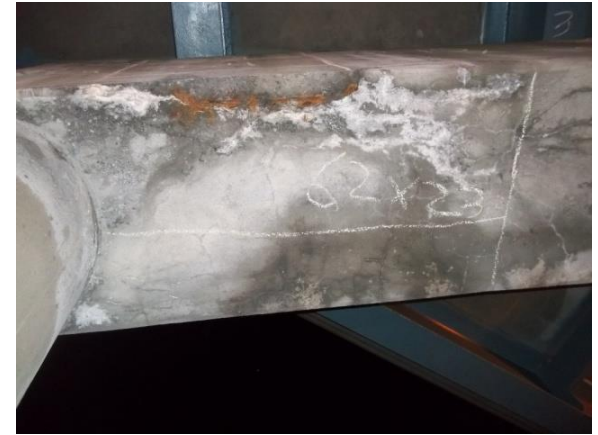
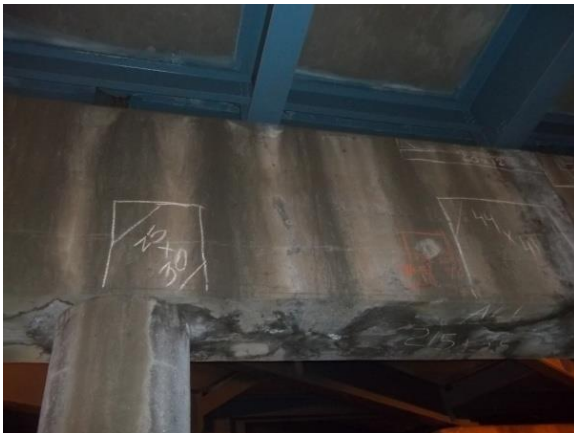
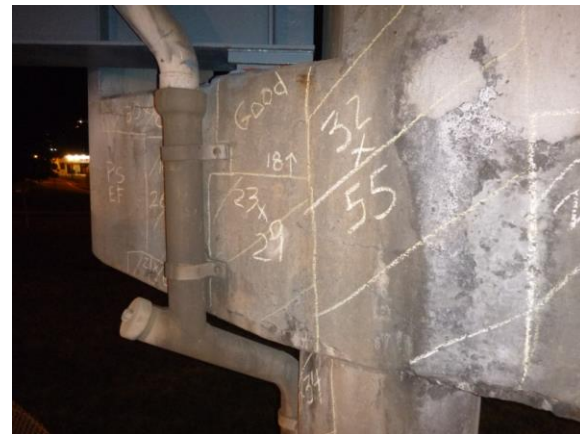
# Visual Conditions

- Built: 1968
- Regular reinforced concrete
- 5 Spans, 4 piers, 2 abutments
- Previous condition rating: 5 (fair) in the 2014 NBI inspection

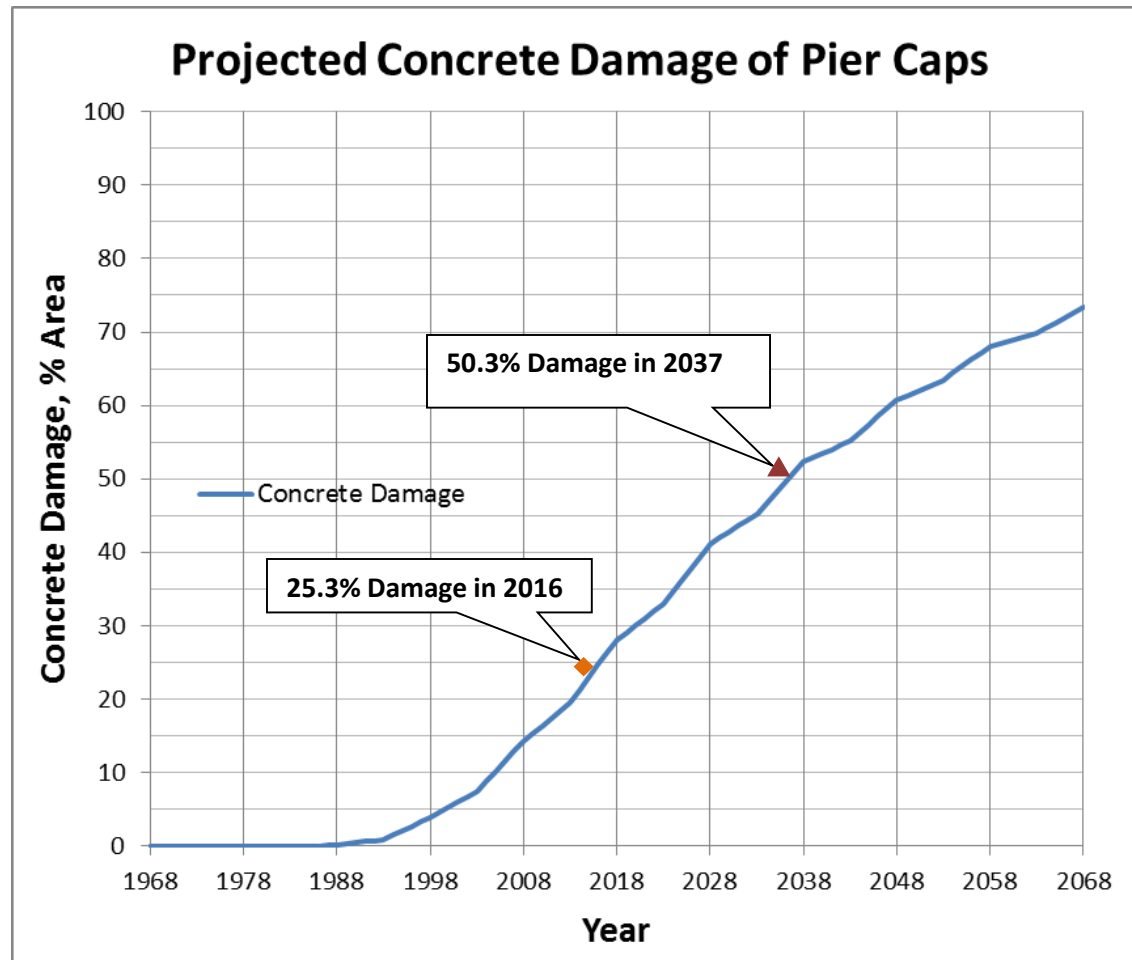
# Service Life Processing – Pier Caps

Element	% Damage	Avg. Cover (in)	95% Cover (in)	Cl% over 1000 ppm	Cl% over 500 ppm	Avg. Diffusion Coeff. (in <sup>2</sup> /yr)	Carbonation Depth (in)	Petro. Analysis
Pier Caps	25.3	2.06	1.01	60%	60%	0.070	0.50	Generally good quality concrete
Pier Columns	17.3	2.50	1.48	17%	17%	0.018	1.15	
Abutments	4.2	2.67	1.15	25%	25%	0.039	0.64

- Viable repair options:
  - A. Patch repairs + Impressed Current Cathodic Protection (ICCP)
  - B. Patch repairs + Electrochemical Chloride Extraction (ECE) + a breathable sealer, or
  - C. Patch repairs + sprayed Galvanic Cathodic Protection (GCP) system
