# Various Rebar Types: Pros and Cons

*Structural Performance and Corrosion Resistance of Corrosion-Resistant Rebars for Concrete Bridge Decks*

Bridge Workers, Supervisors & Engineers Conference, Mt. Sterling, OH

April 16, 2015

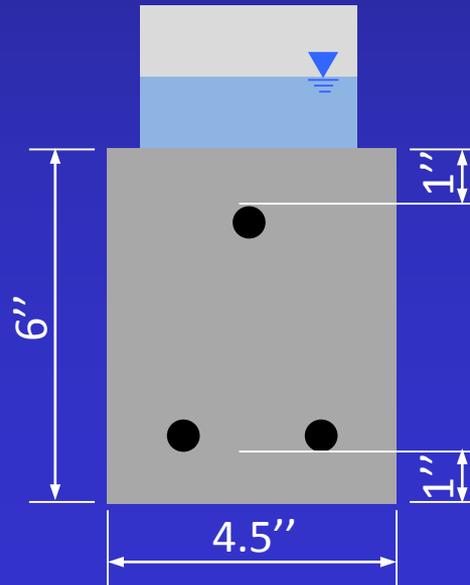
- ASTM G109
  - evaluate concrete admixtures
  - uncracked specimen
  - 3% sodium chloride solution

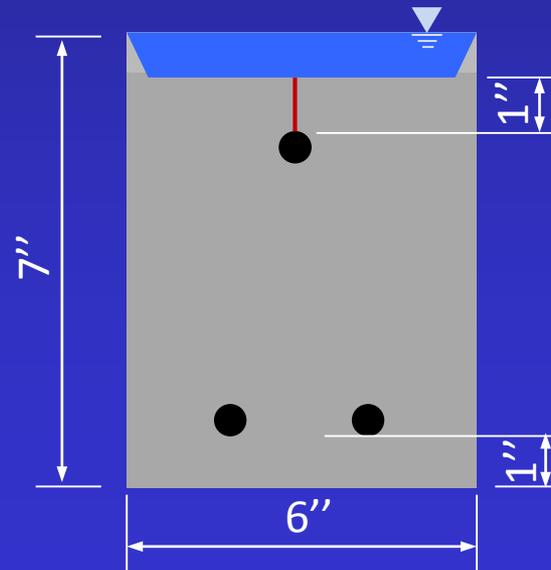
- ASTM A955
  - to evaluate stainless steel reinforcement
  - cracked specimen with artificial cracks
  - 15% sodium chloride solution

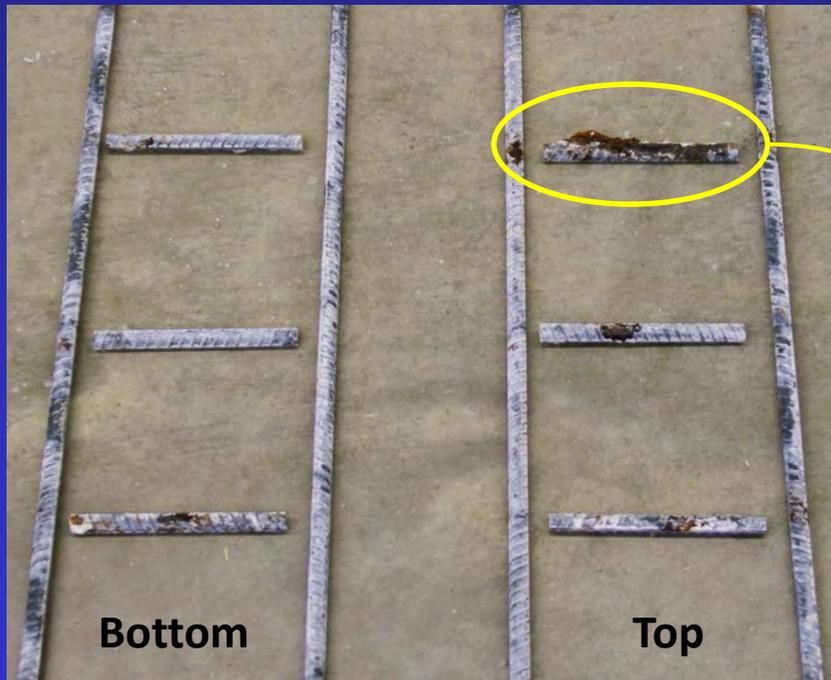
Black

Cracked specimens with identical bars

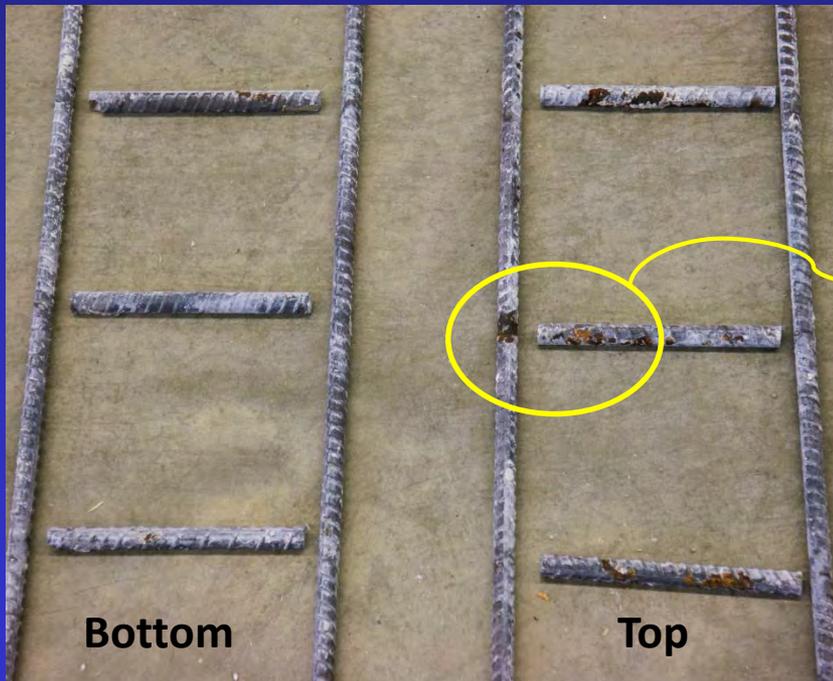
MMFX II

Cracked specimens with identical bars

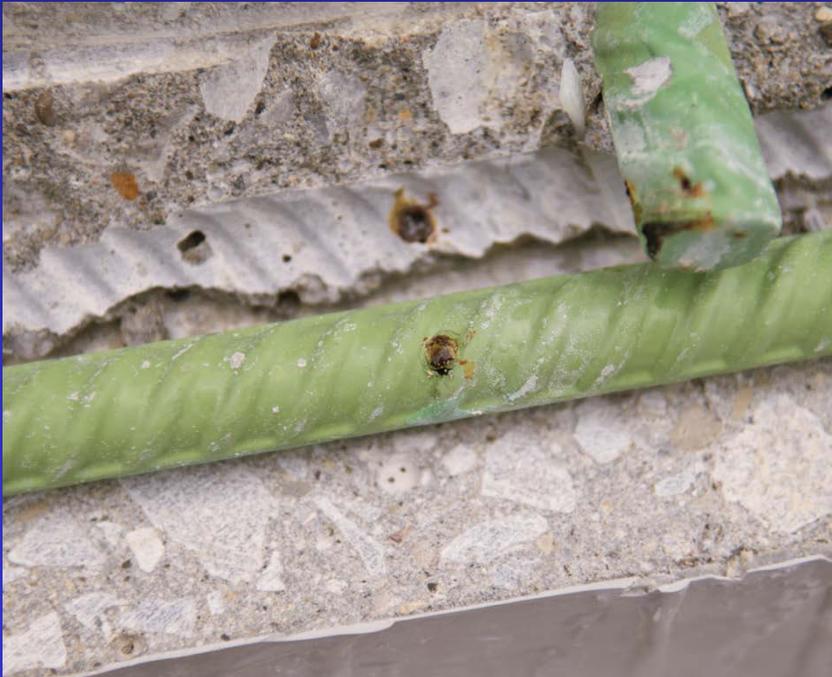
Epoxy coated

Cracked specimens with identical bars

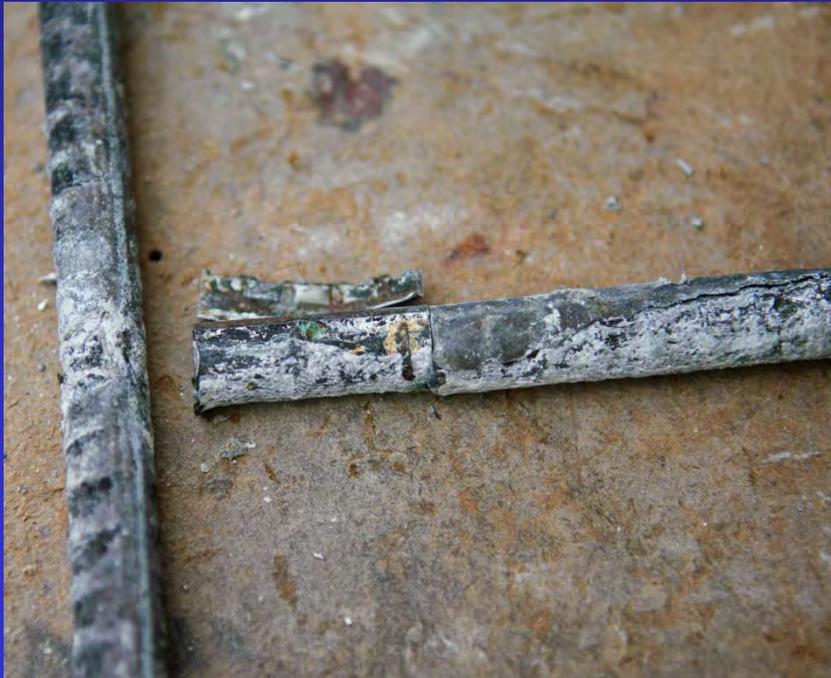
Zinc-clad

Cracked specimens with identical bars

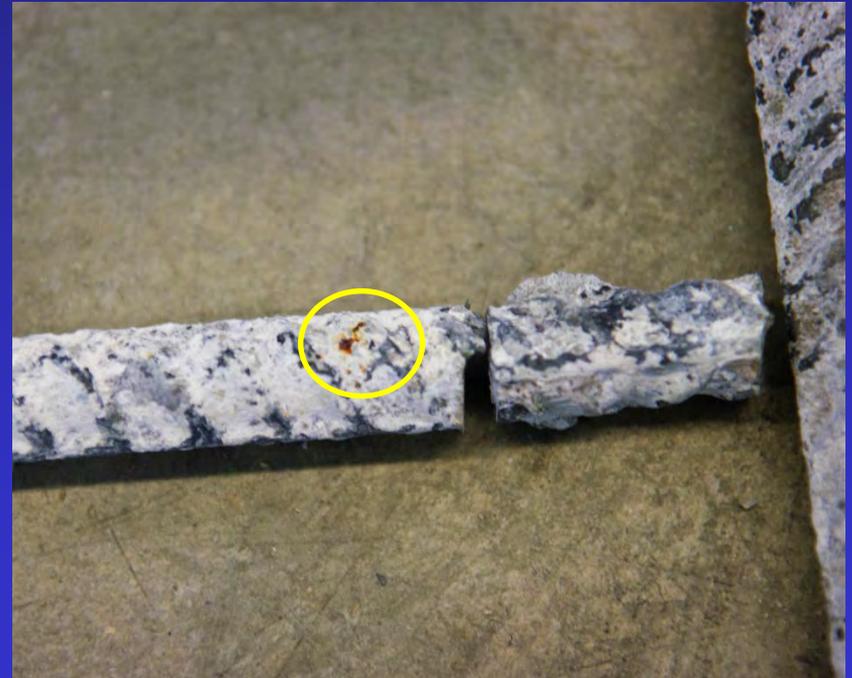
Galvanized

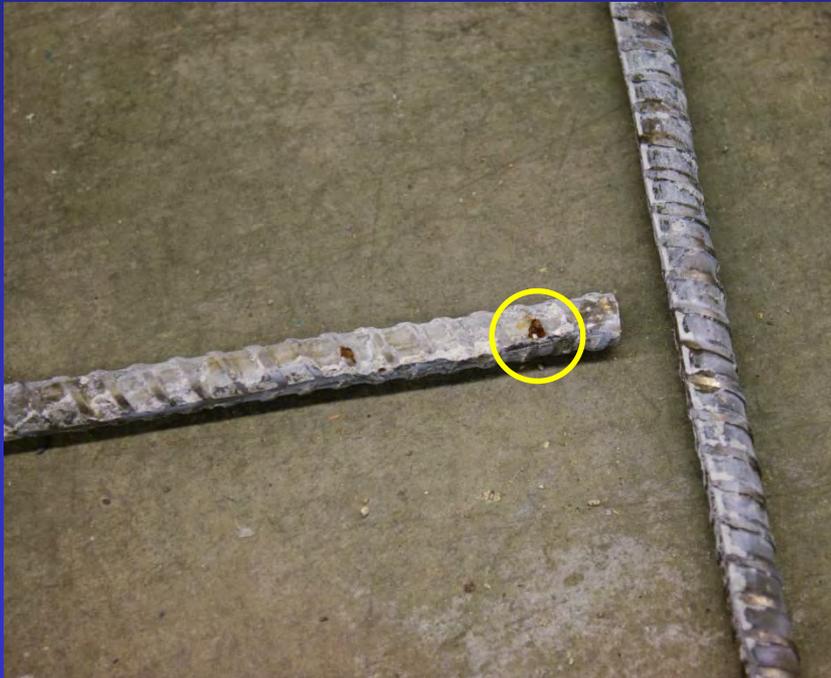
Discoloration and reddish-brown corrosion products

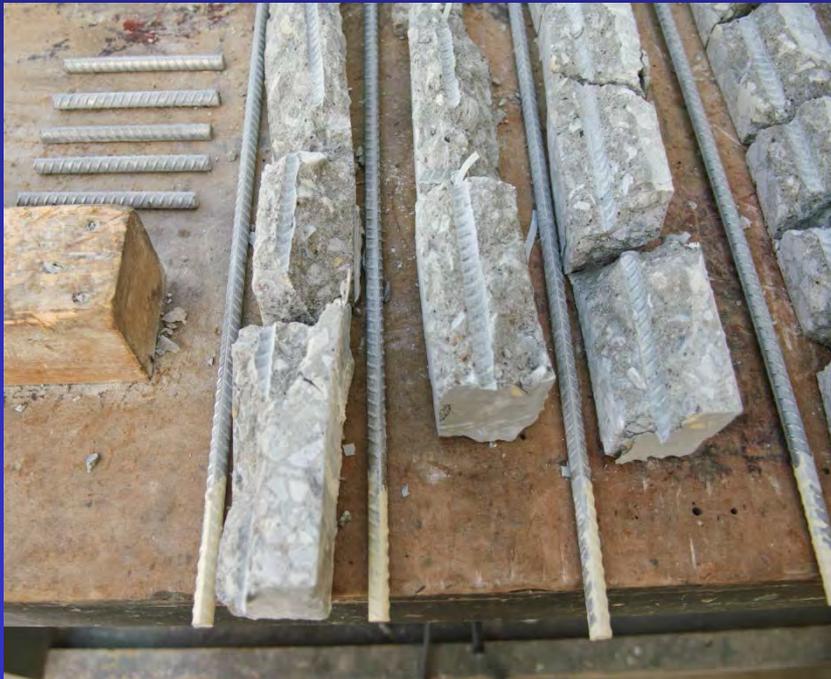
316LN

Cracked specimens with identical bars

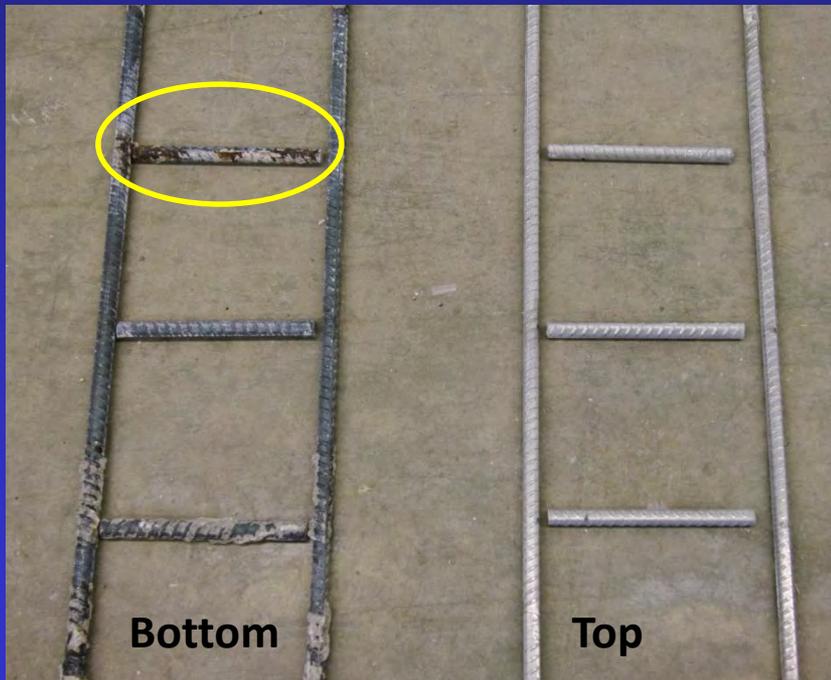
316LN

Cracked specimens with dissimilar bars

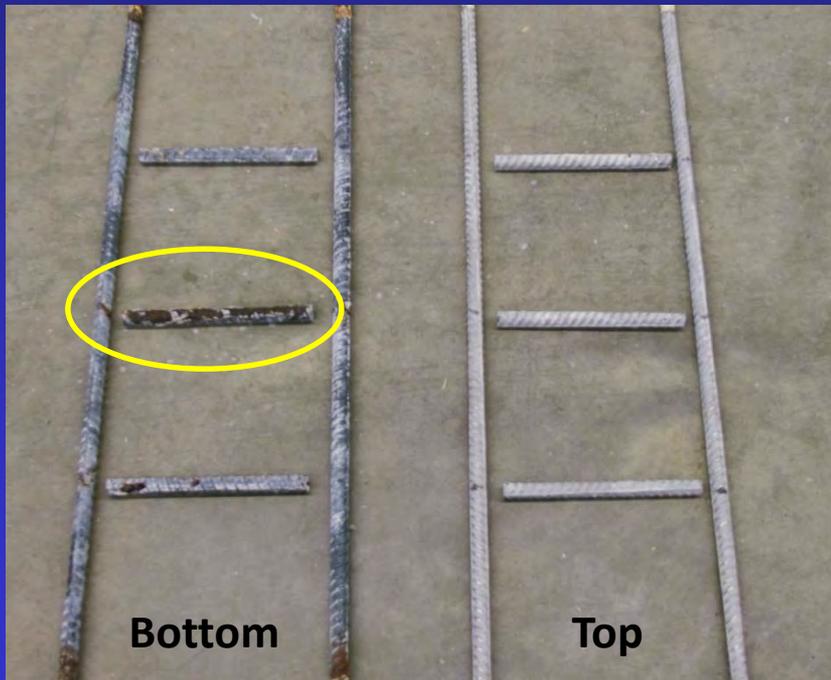
Duplex 2304

Cracked specimens with dissimilar bars

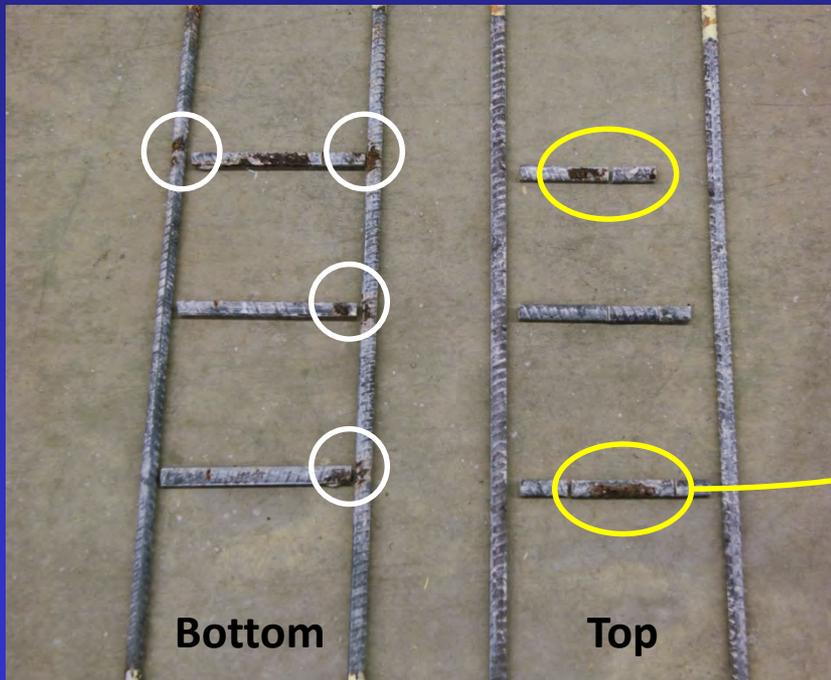
MMFX II

Cracked specimens with dissimilar bars

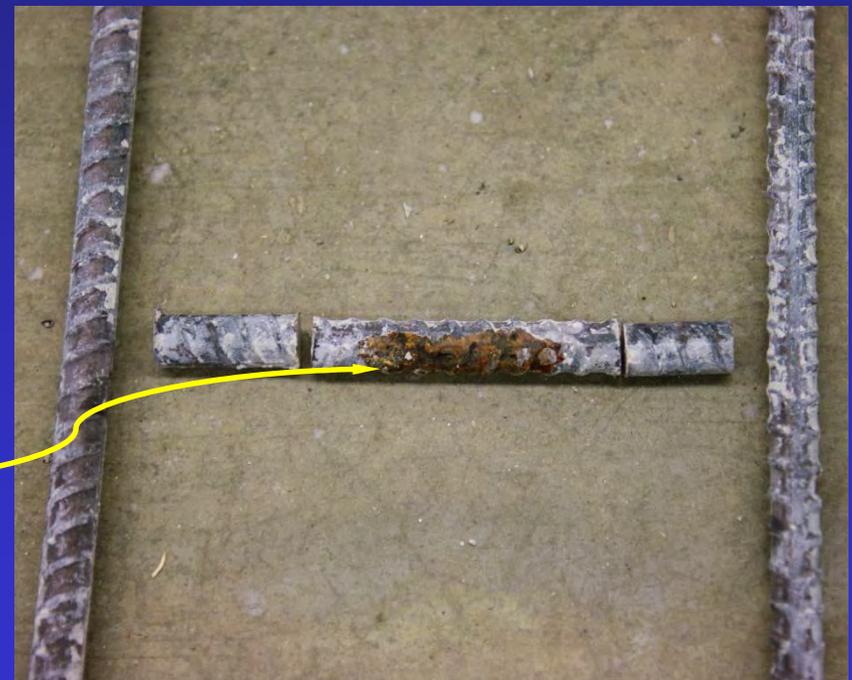
Microcell Corrosion on Top Layer

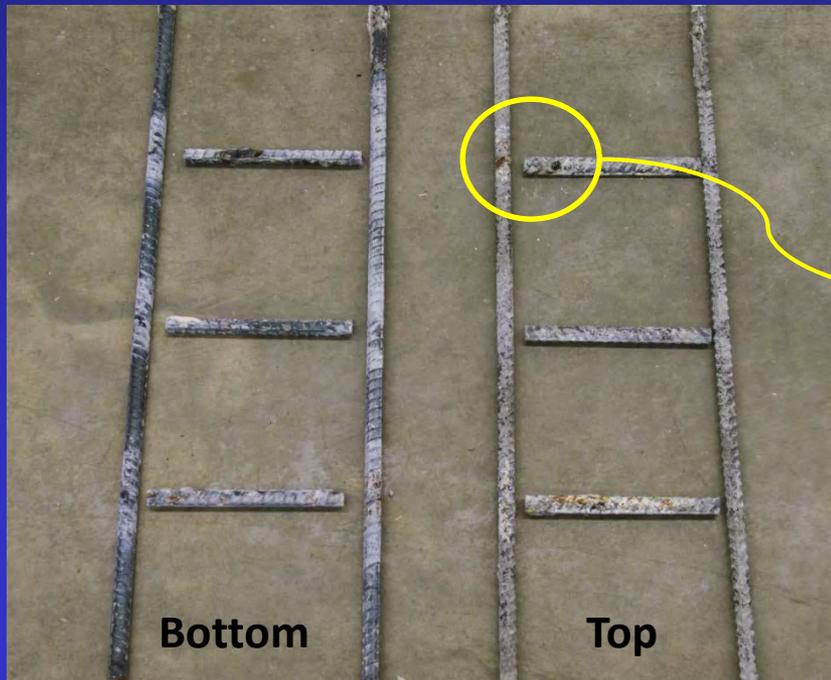
Galvanized

Cracked specimens with dissimilar bars

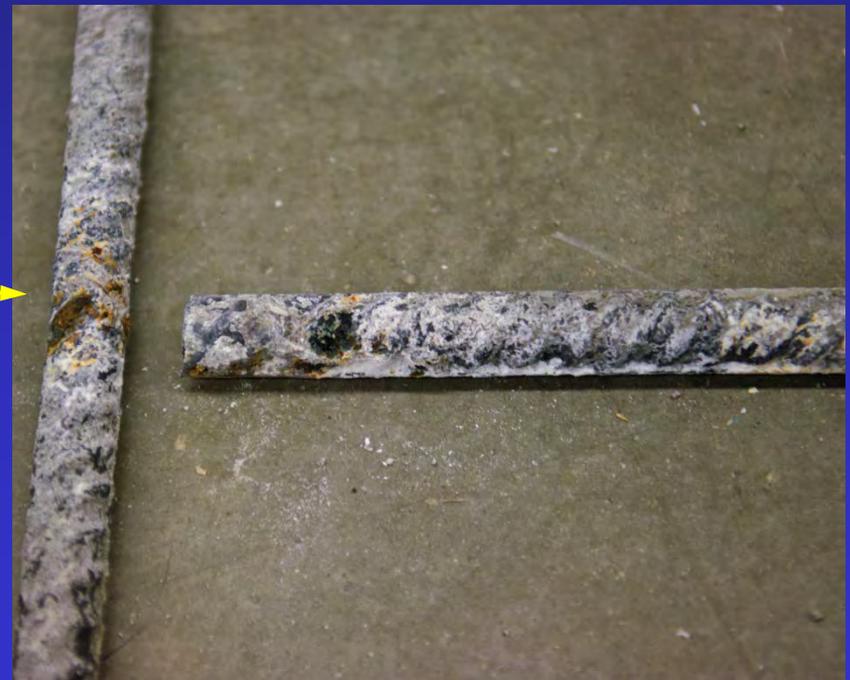
White rust corrosion and iron oxide corrosion
