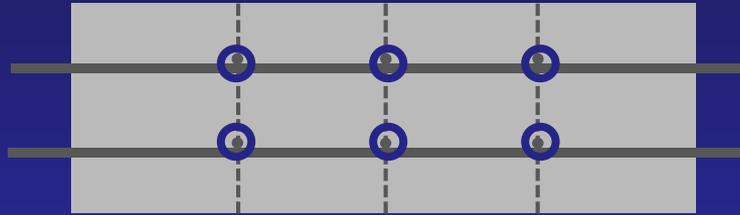
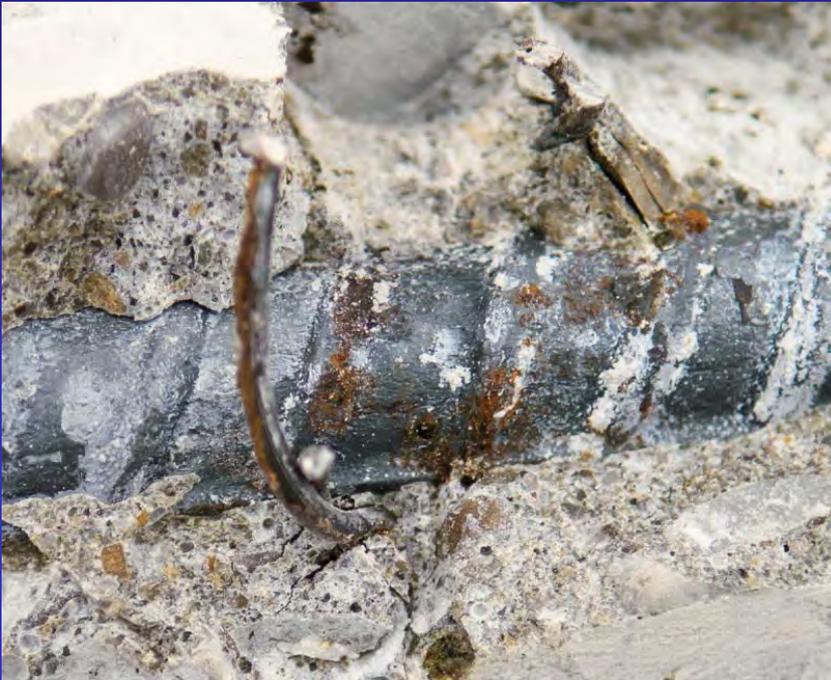
Black w/ BT

Cracked specimens with different ties

- Dissimilar mats cause galvanic corrosion  
Use identical material
- Dissimilar metallic ties cause galvanic coupling  
Use inert (plastic) ties or  
Ties with identical material to rebar

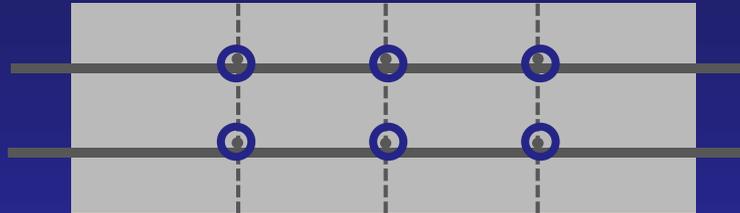
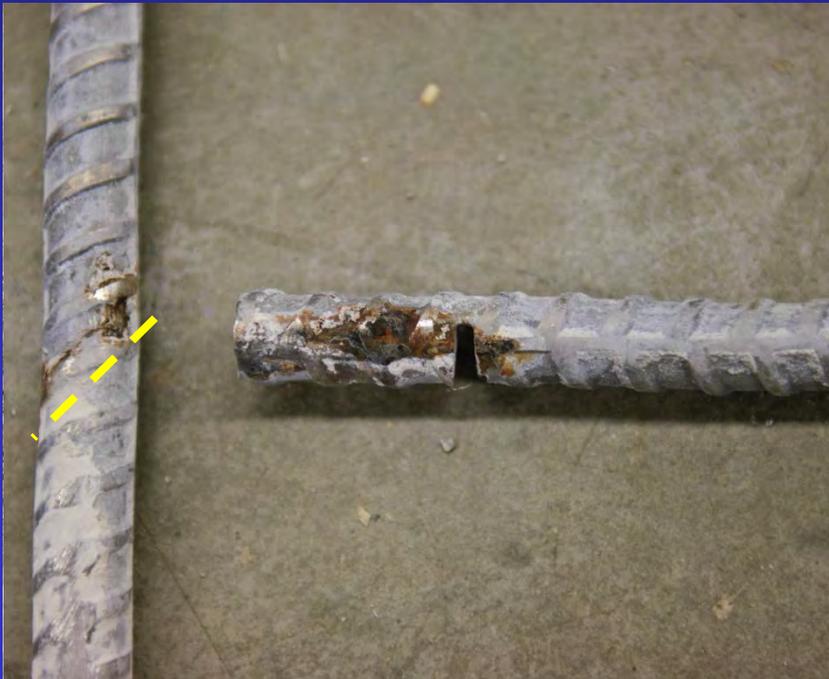
XM28 w/ BT

Cracked specimens with different ties

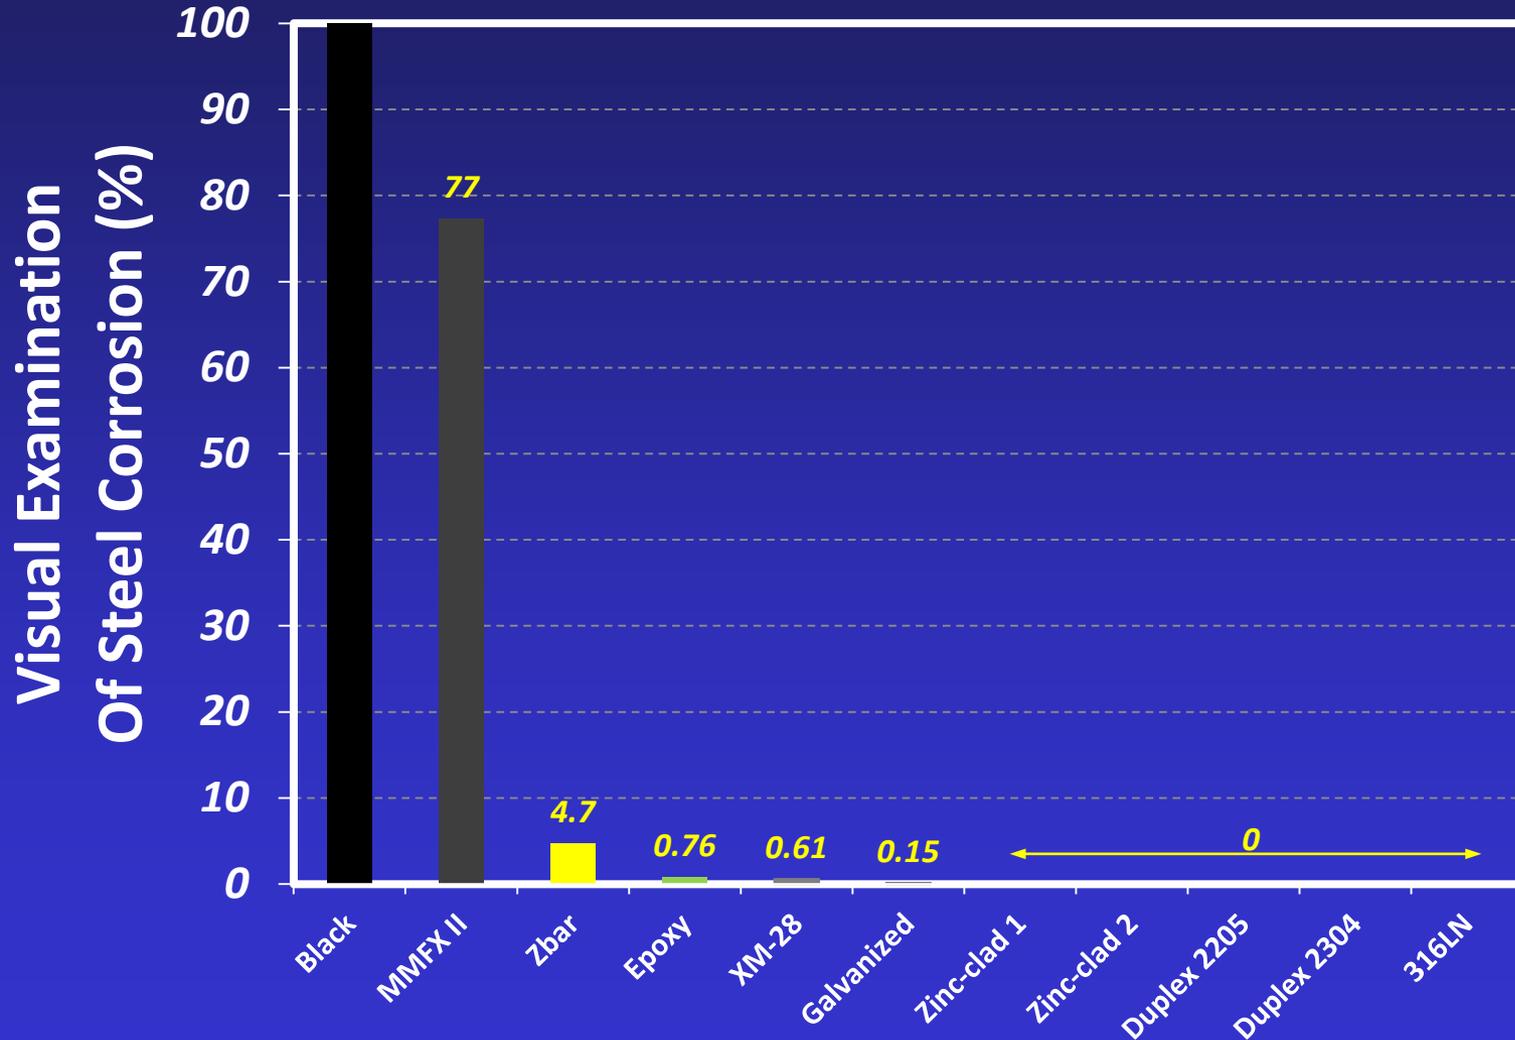
# Visual Examination of Steel Corrosion

(Cracked - Identical mats)

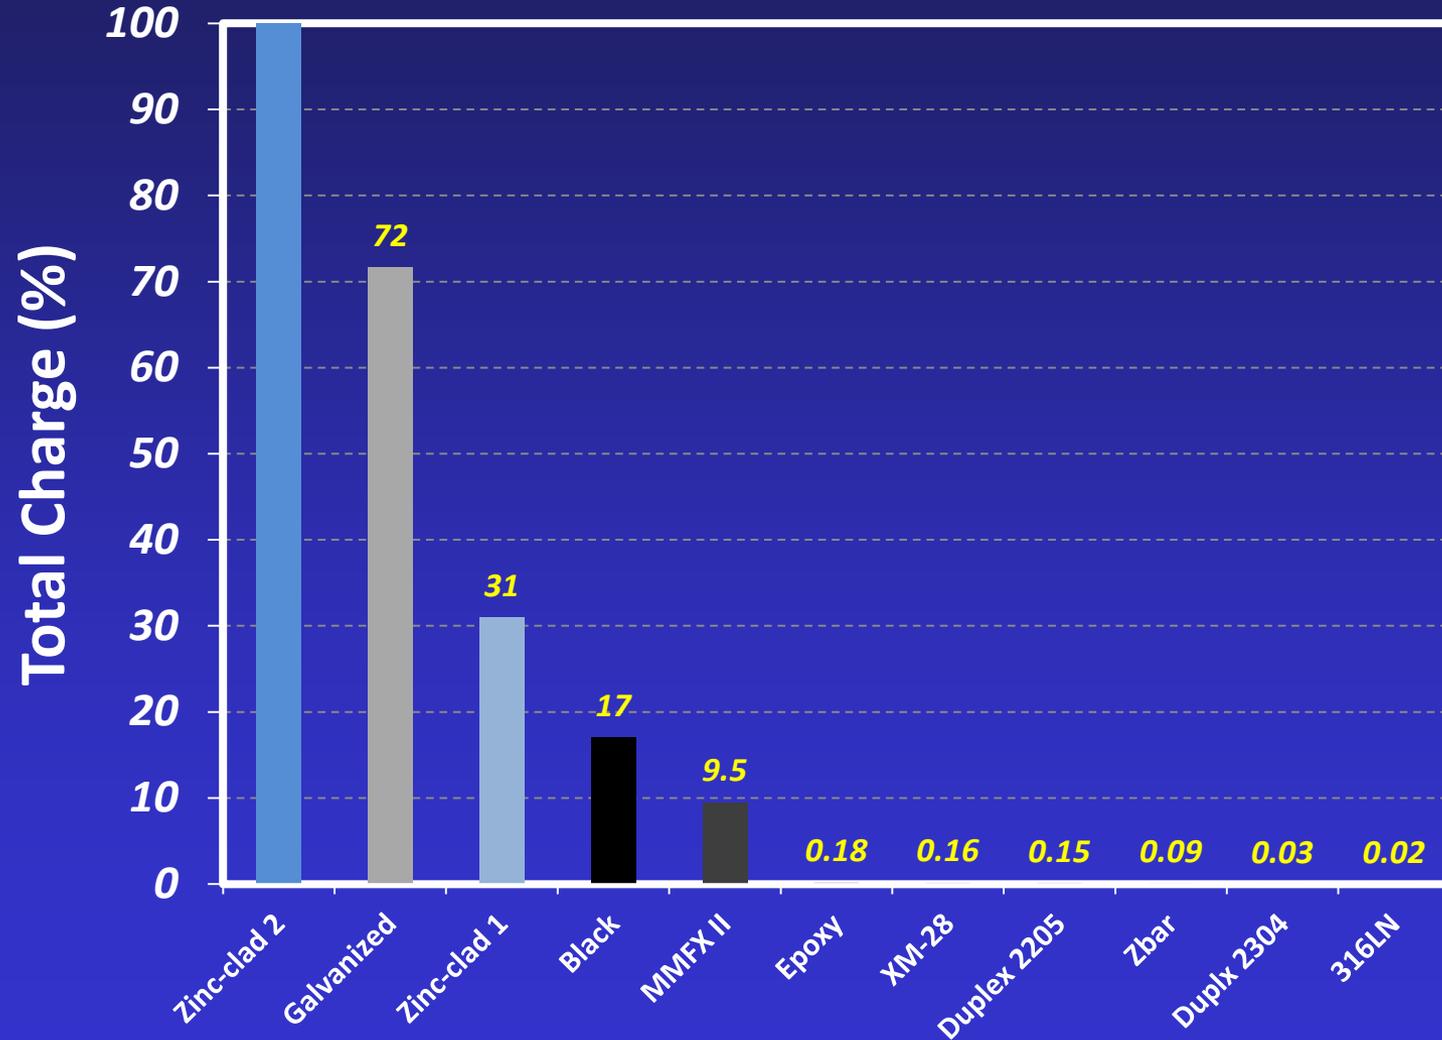
# Total Charge

(Cracked - Identical mats)

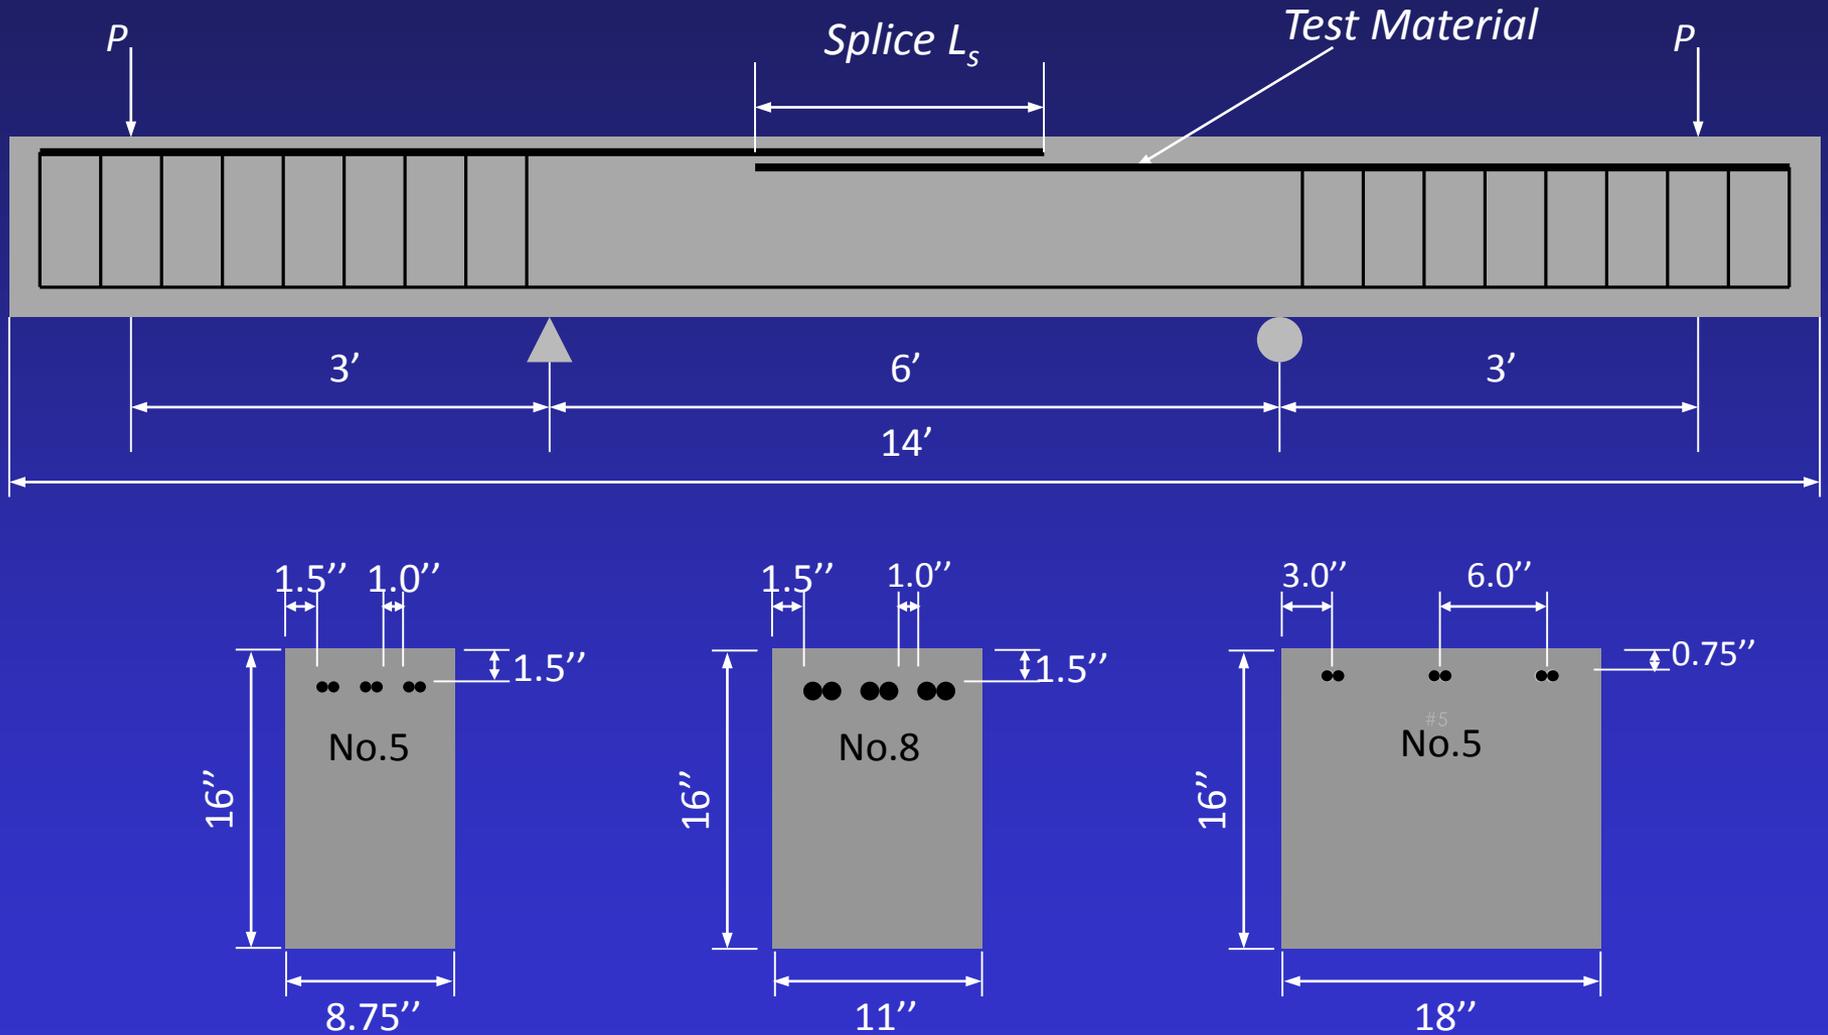
# Lap-splice beam specimen

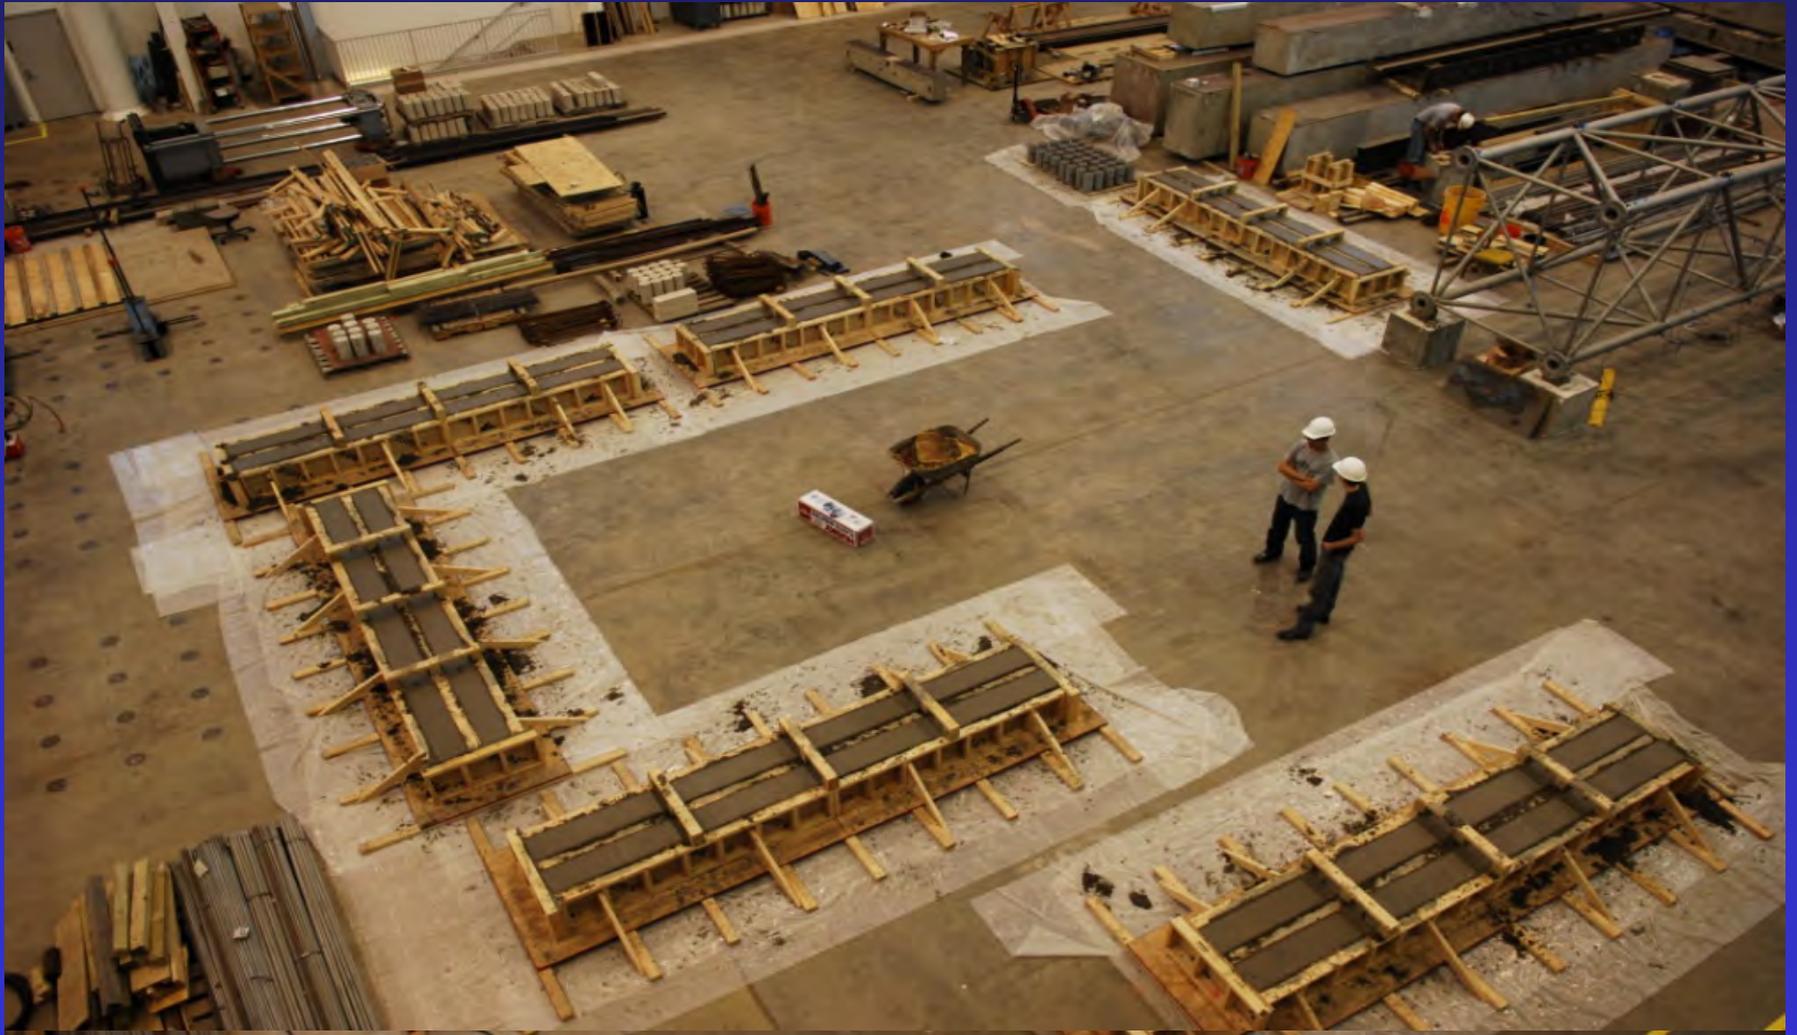
# Construction of Lap-splice beams

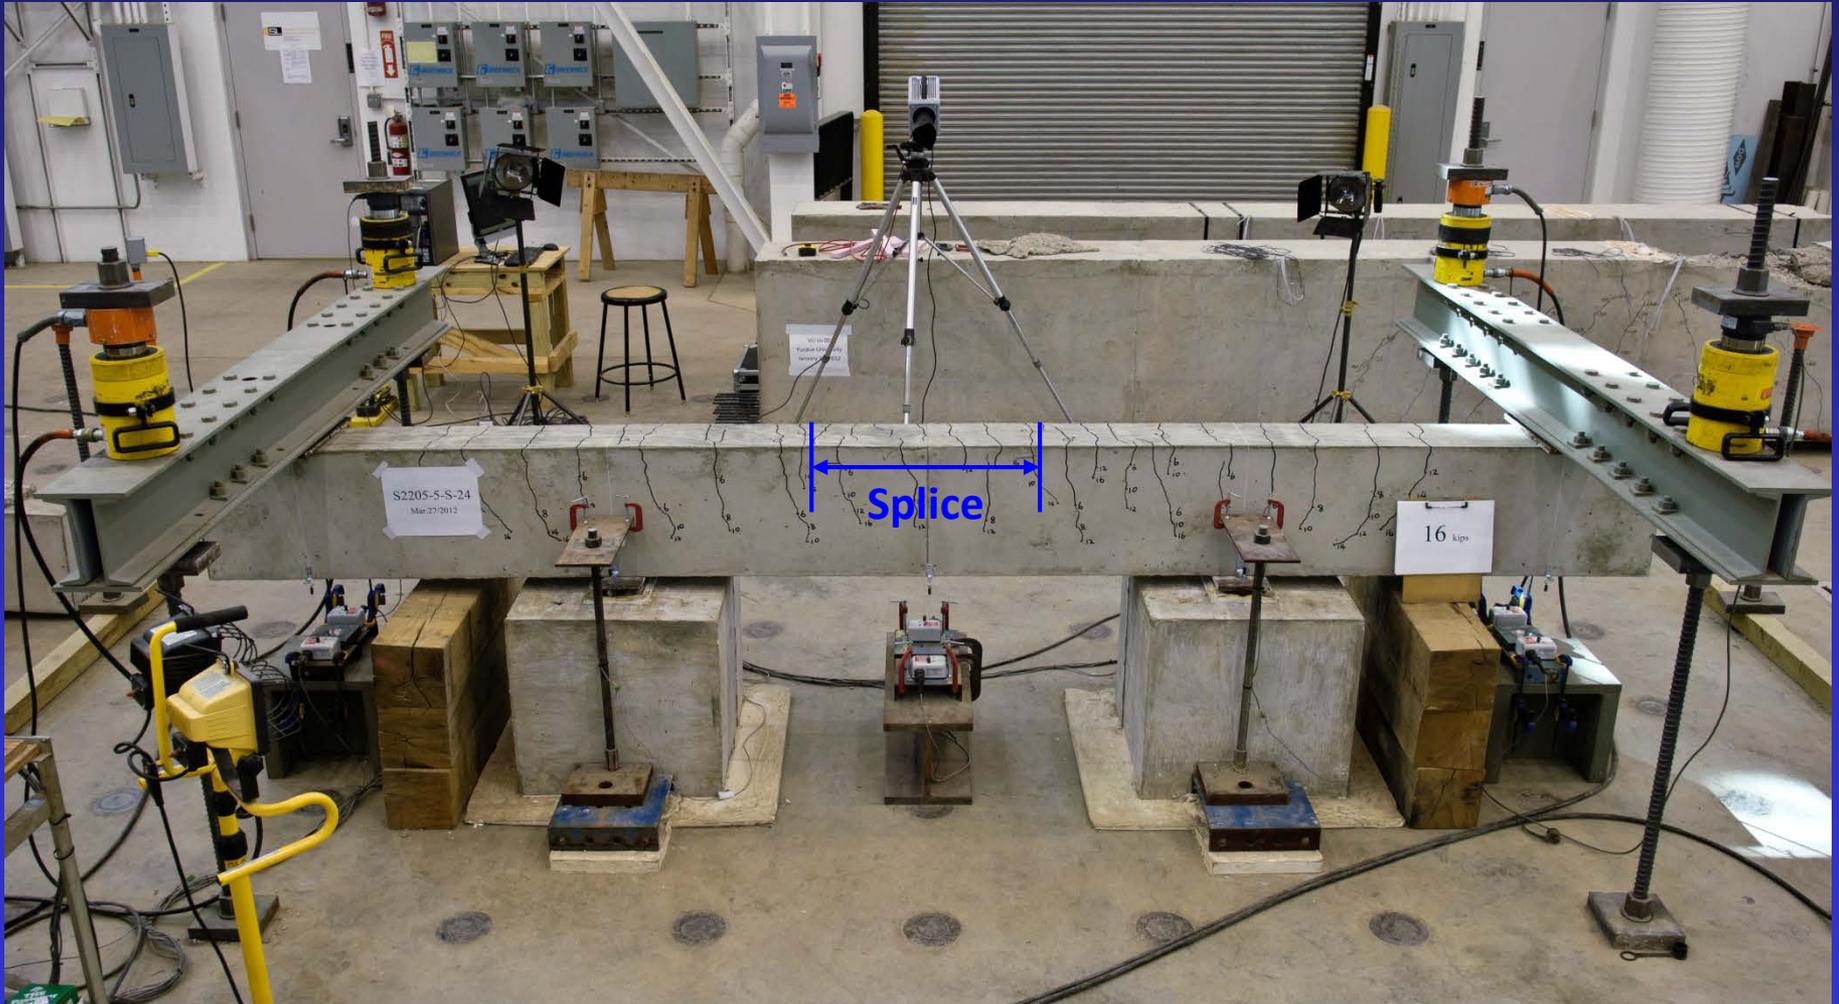
# Test Set-up

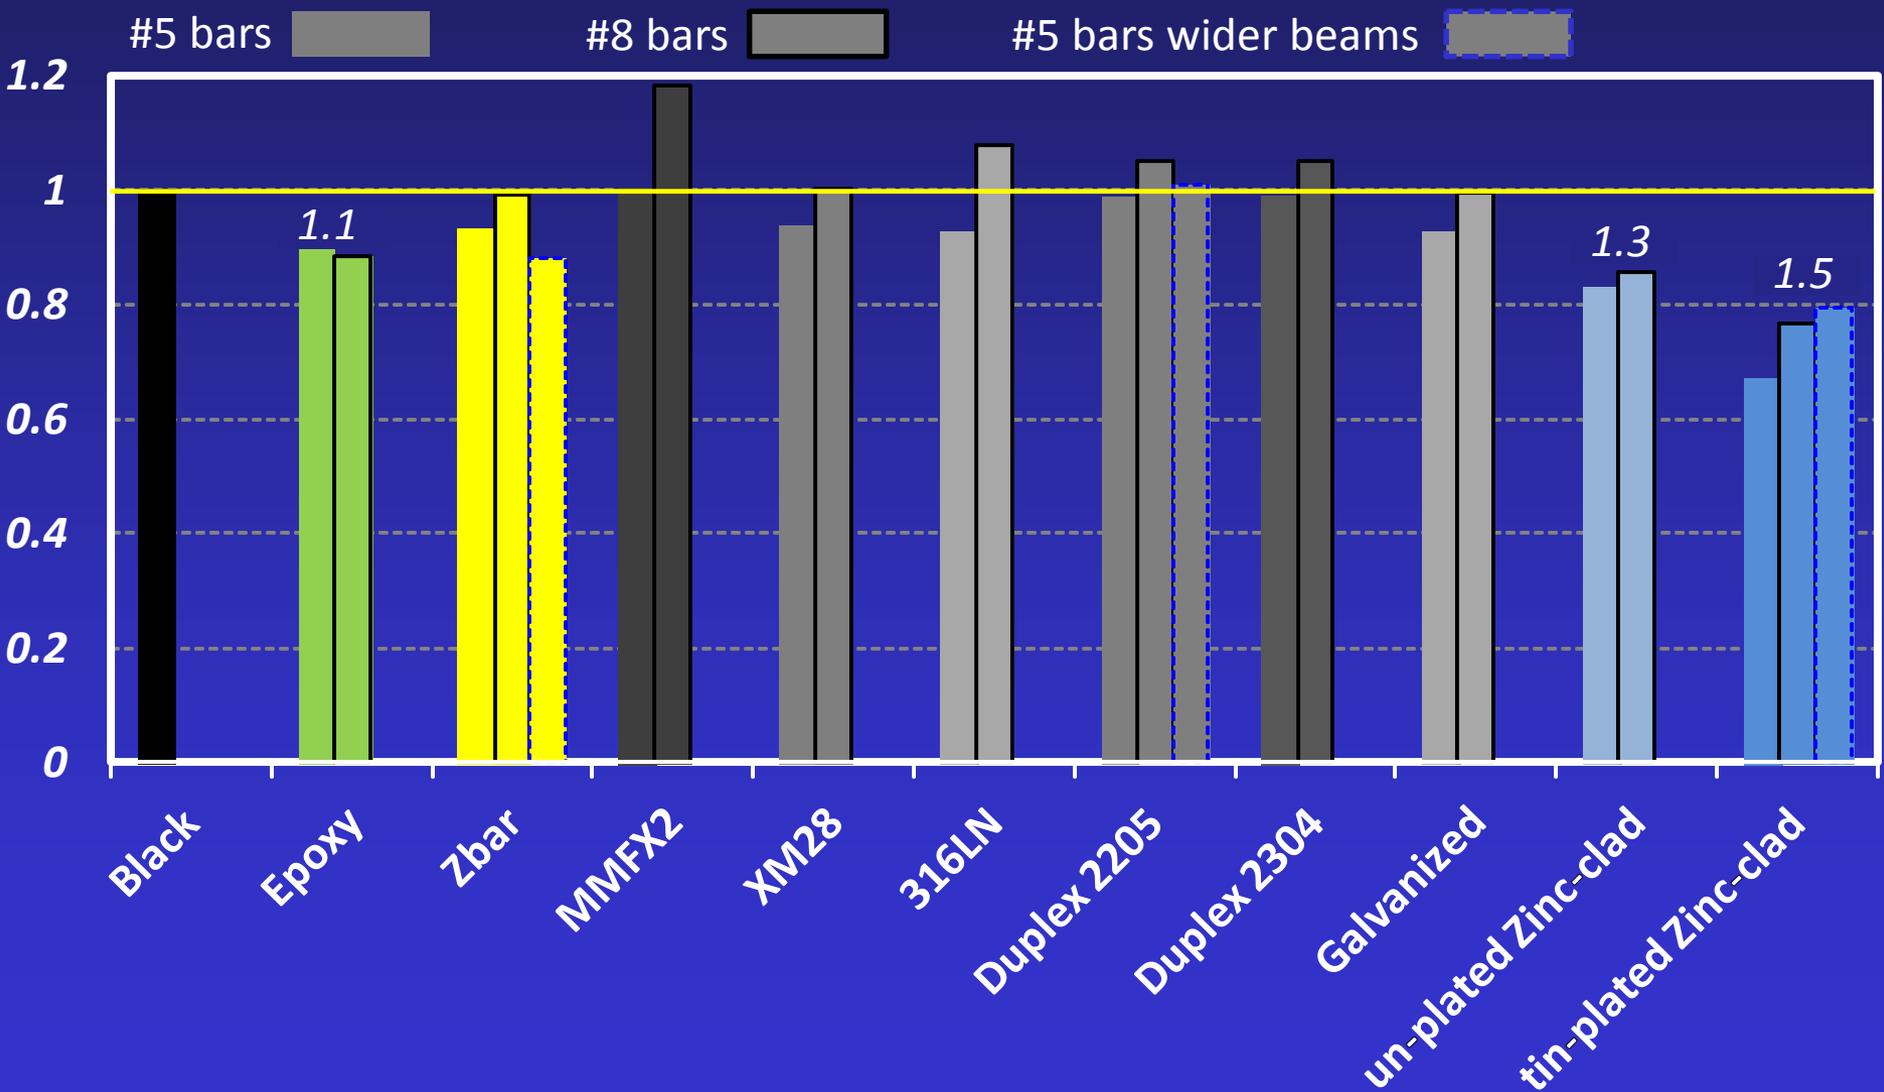
# Bond Ratio

## Measured Bond Strength of Test Bar/Black Bar

- **Bond Ratio**
  - MMFX2, Duplex 2205, Duplex 2304, 316LN = Black
  - Black > XM28 (97%), Galvanized (96%), Zbar (94%)  
> Epoxy (89%) > Zinc-clad (79%)
- **Relative Rib Ratio**
  - Low influential to bond strength
- **Surface Roughness and Coating Thickness**
  - High correlation to bond strength

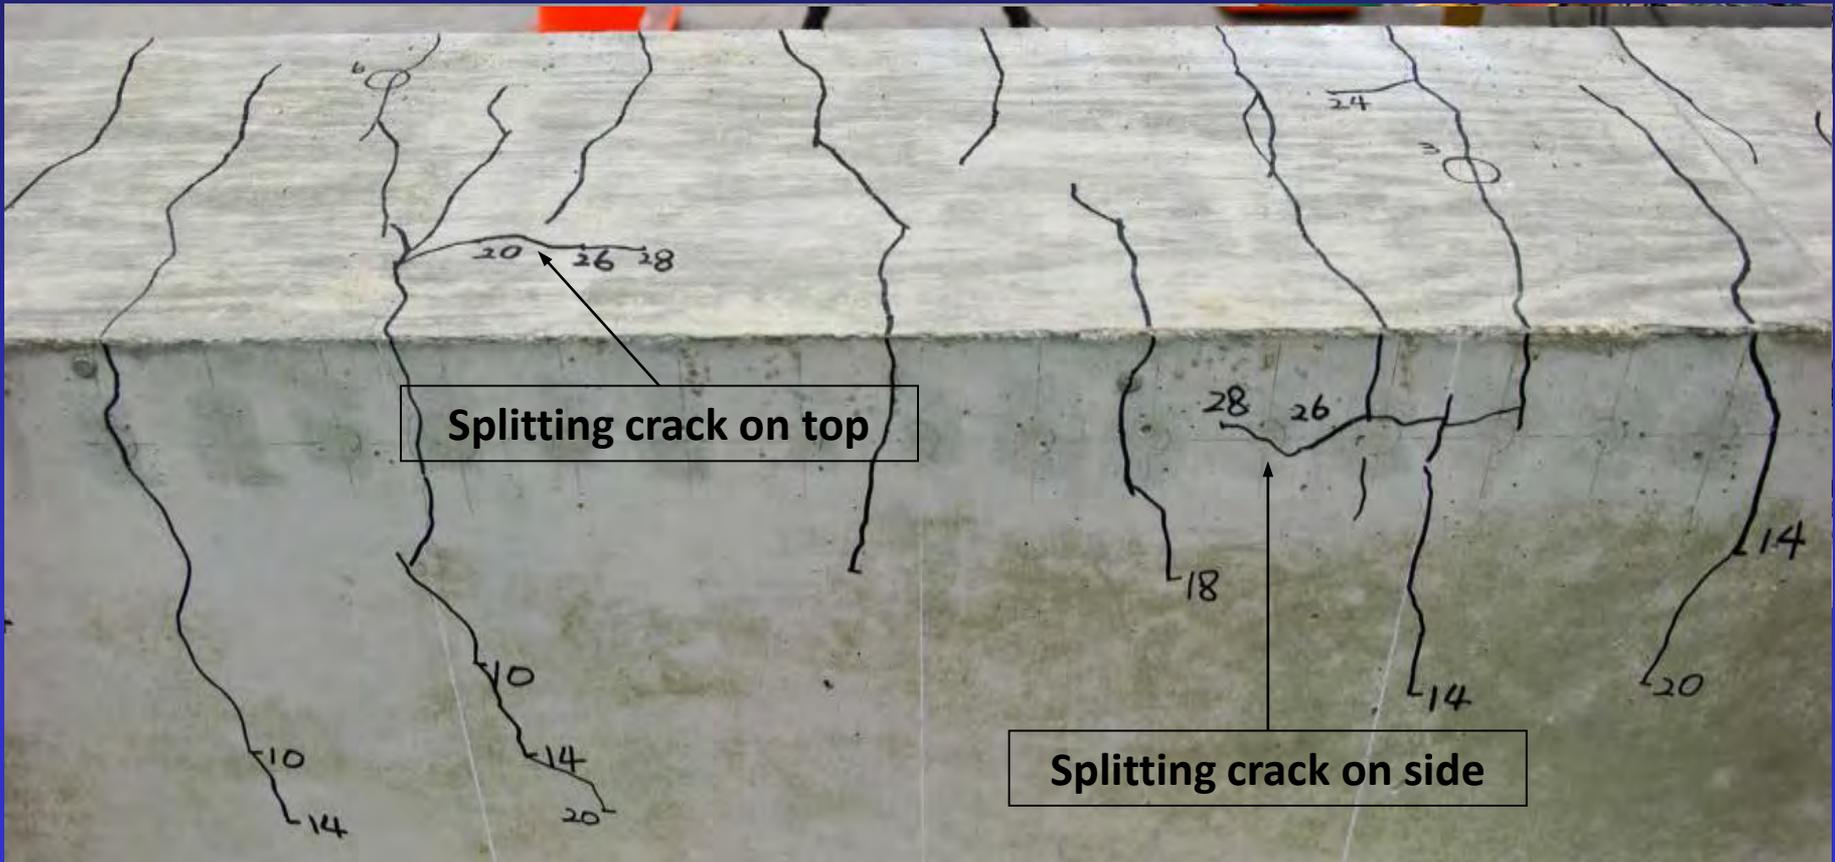
# Splitting Cracks prior to Failure

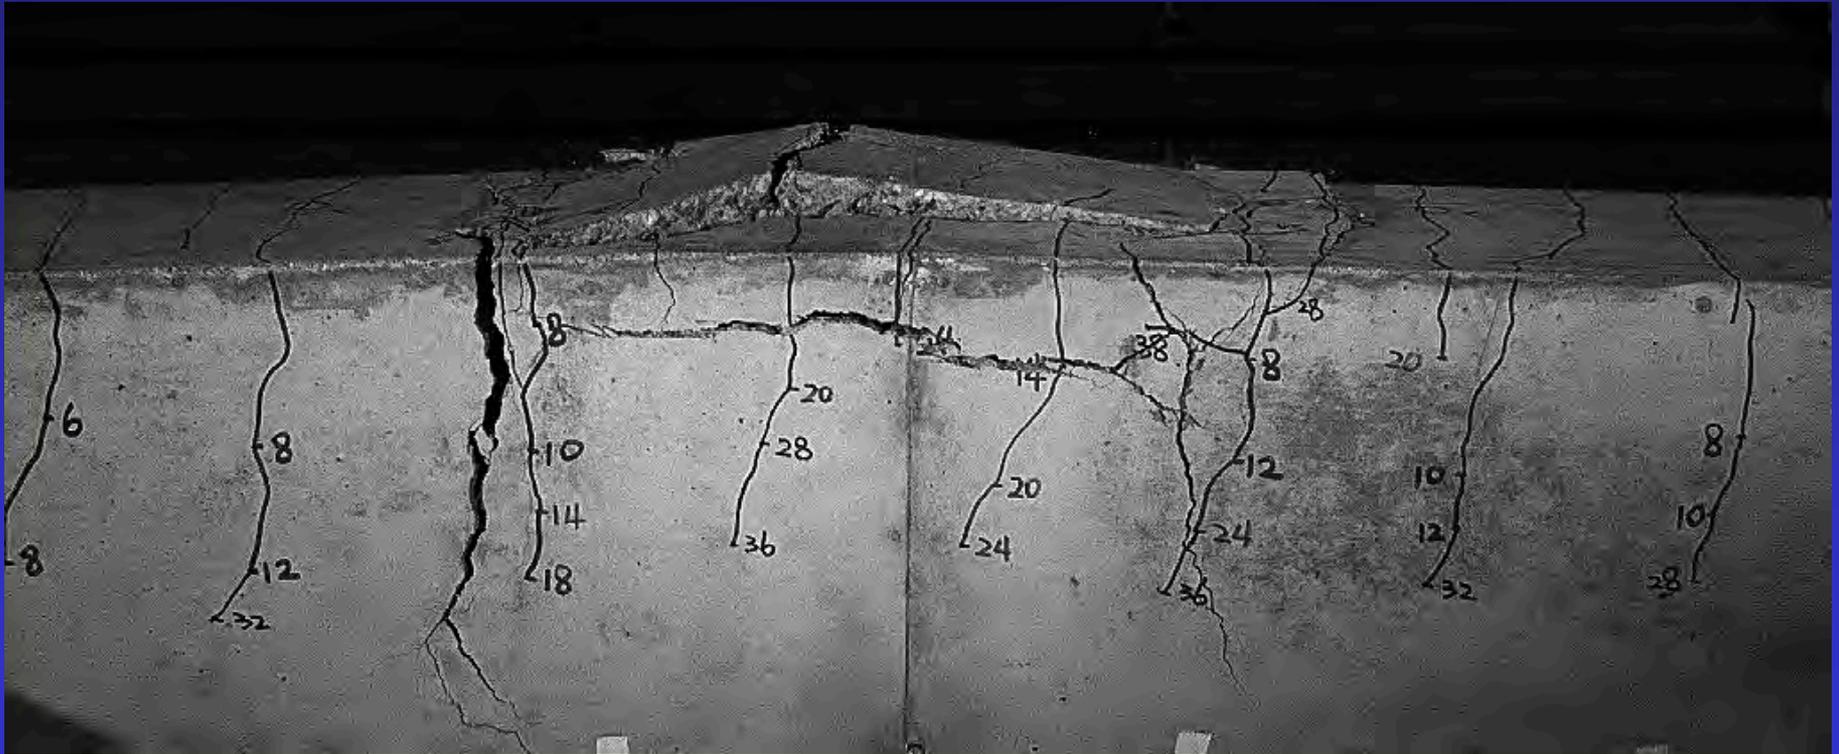
# Failure Modes

Face and Side Splitting Mode (Black, #8 bars, 24 in. splice, Confined)

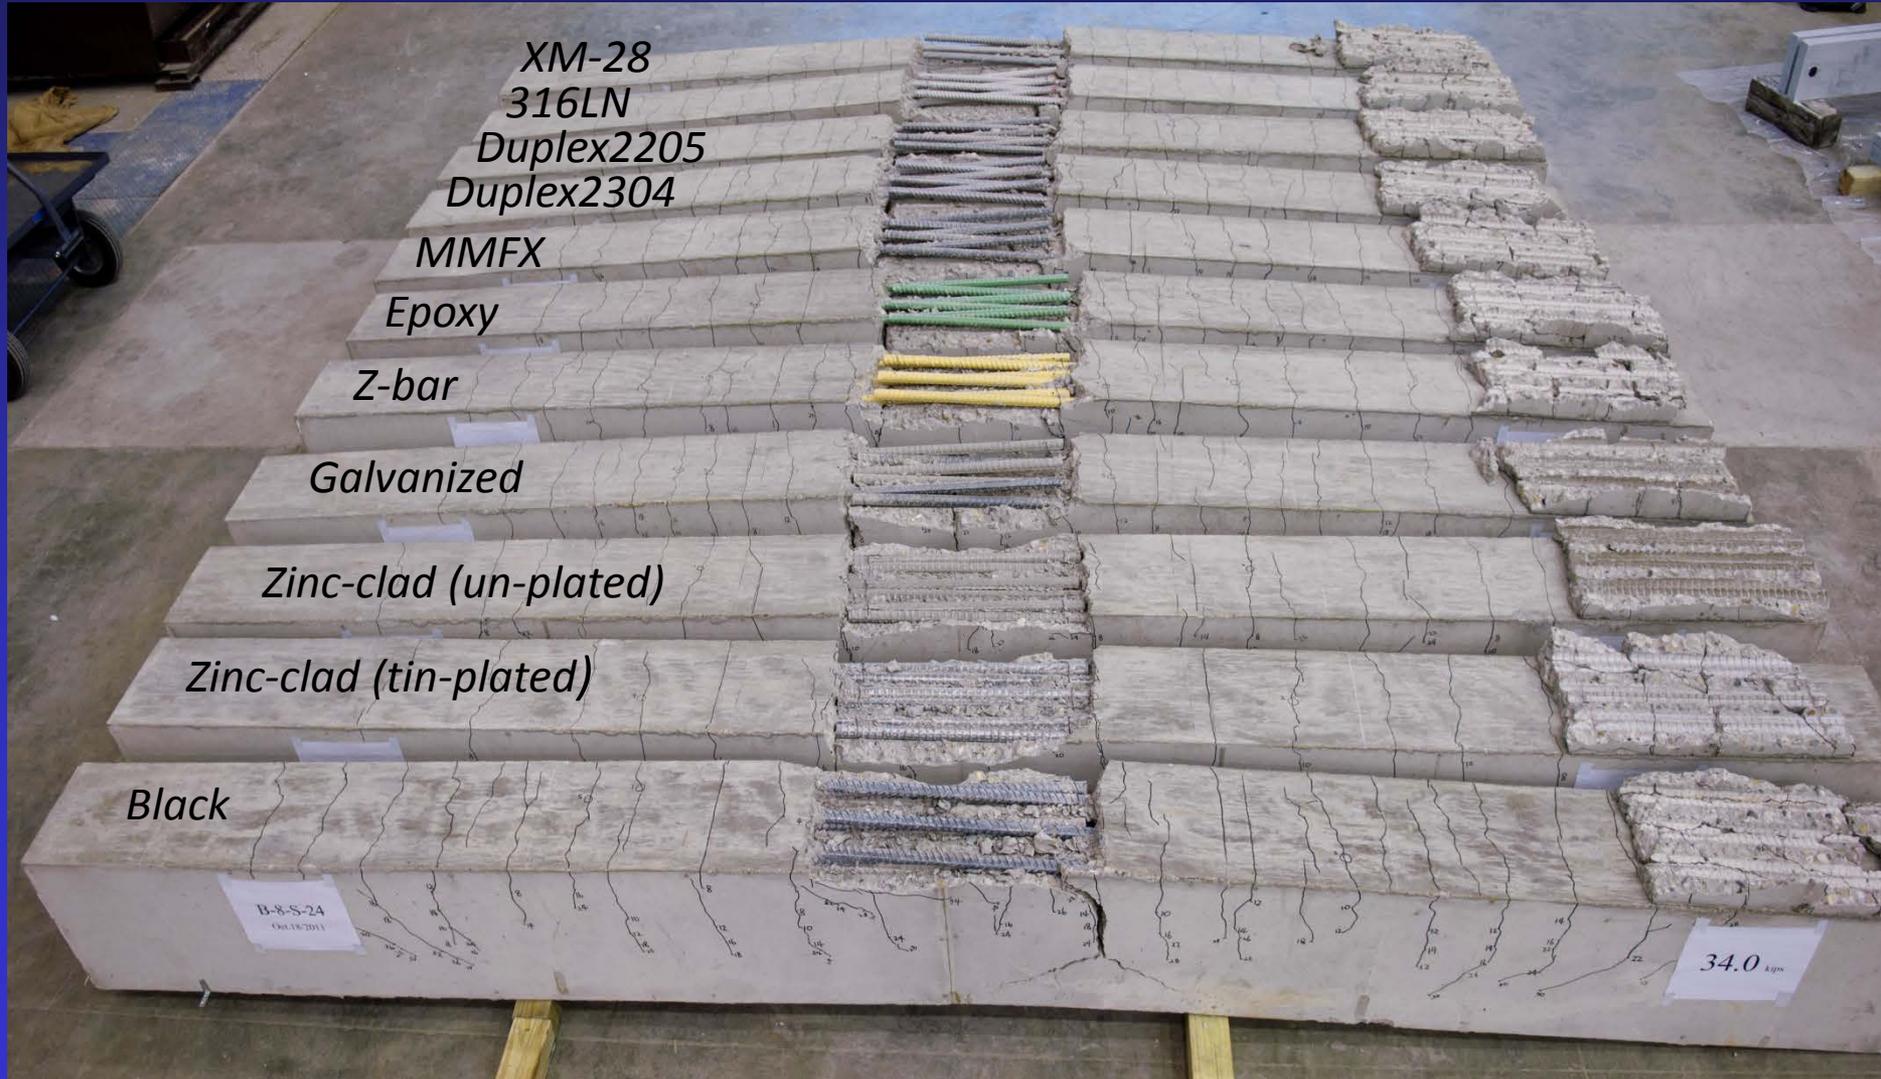
# Crack Pattern

No.8, side splitting failure, 24 in. splice

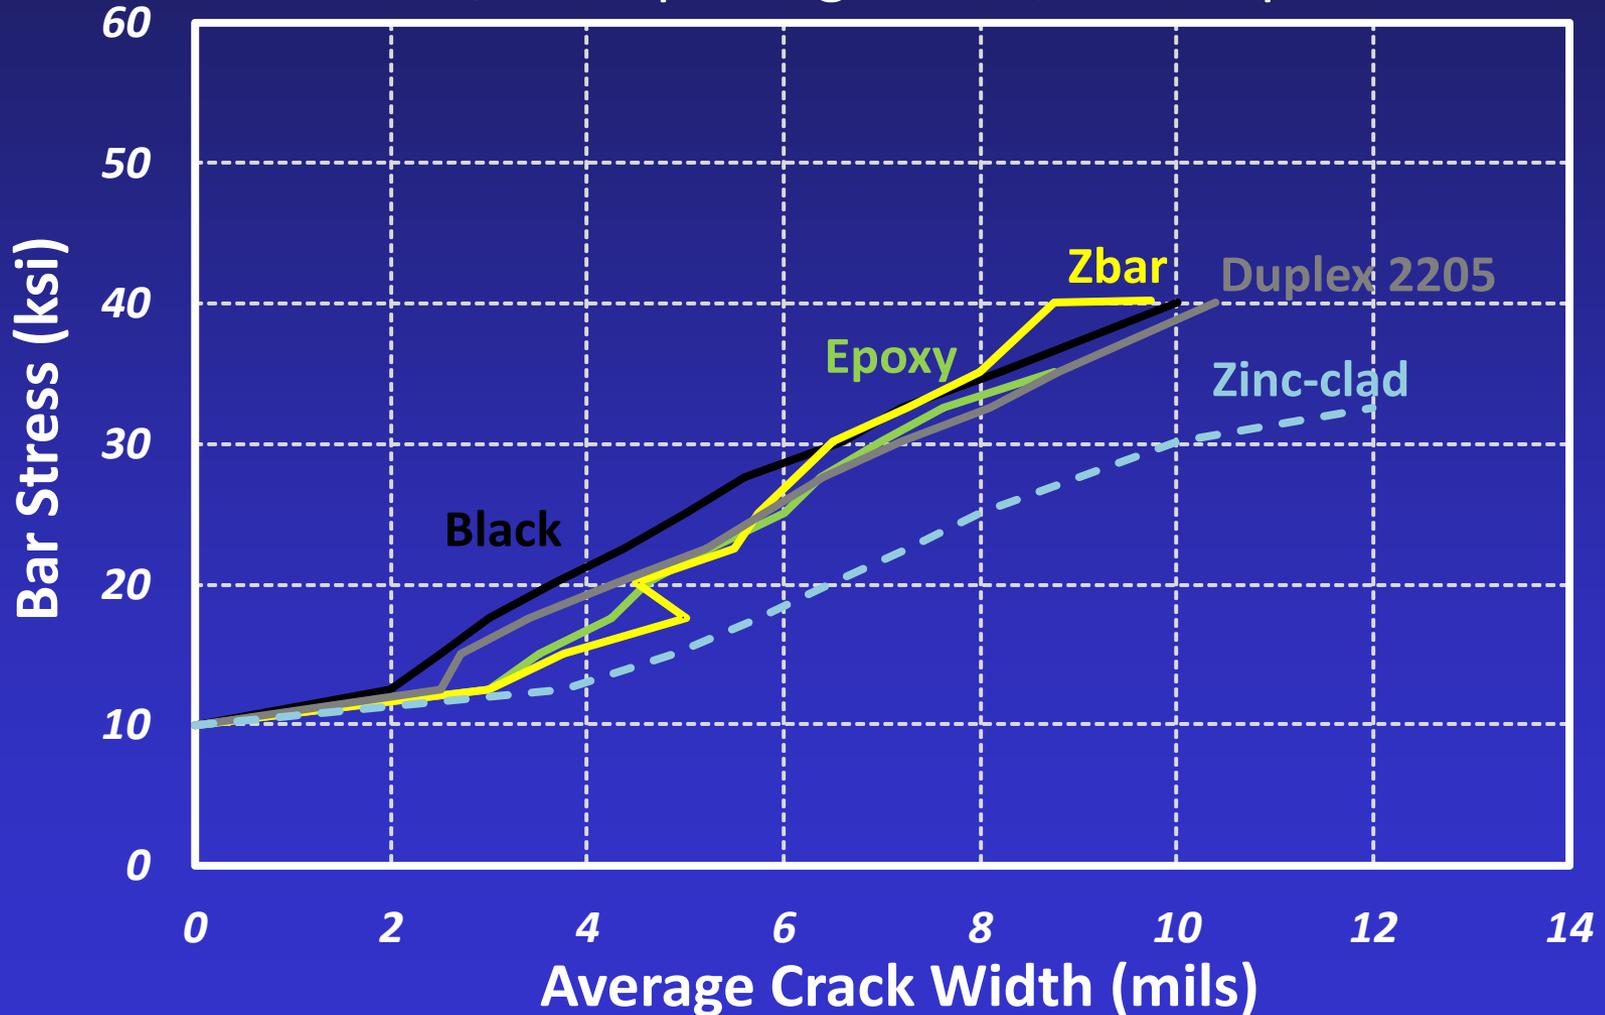
# Bar stress vs. crack width

No.8, side splitting failure, 24 in. splice

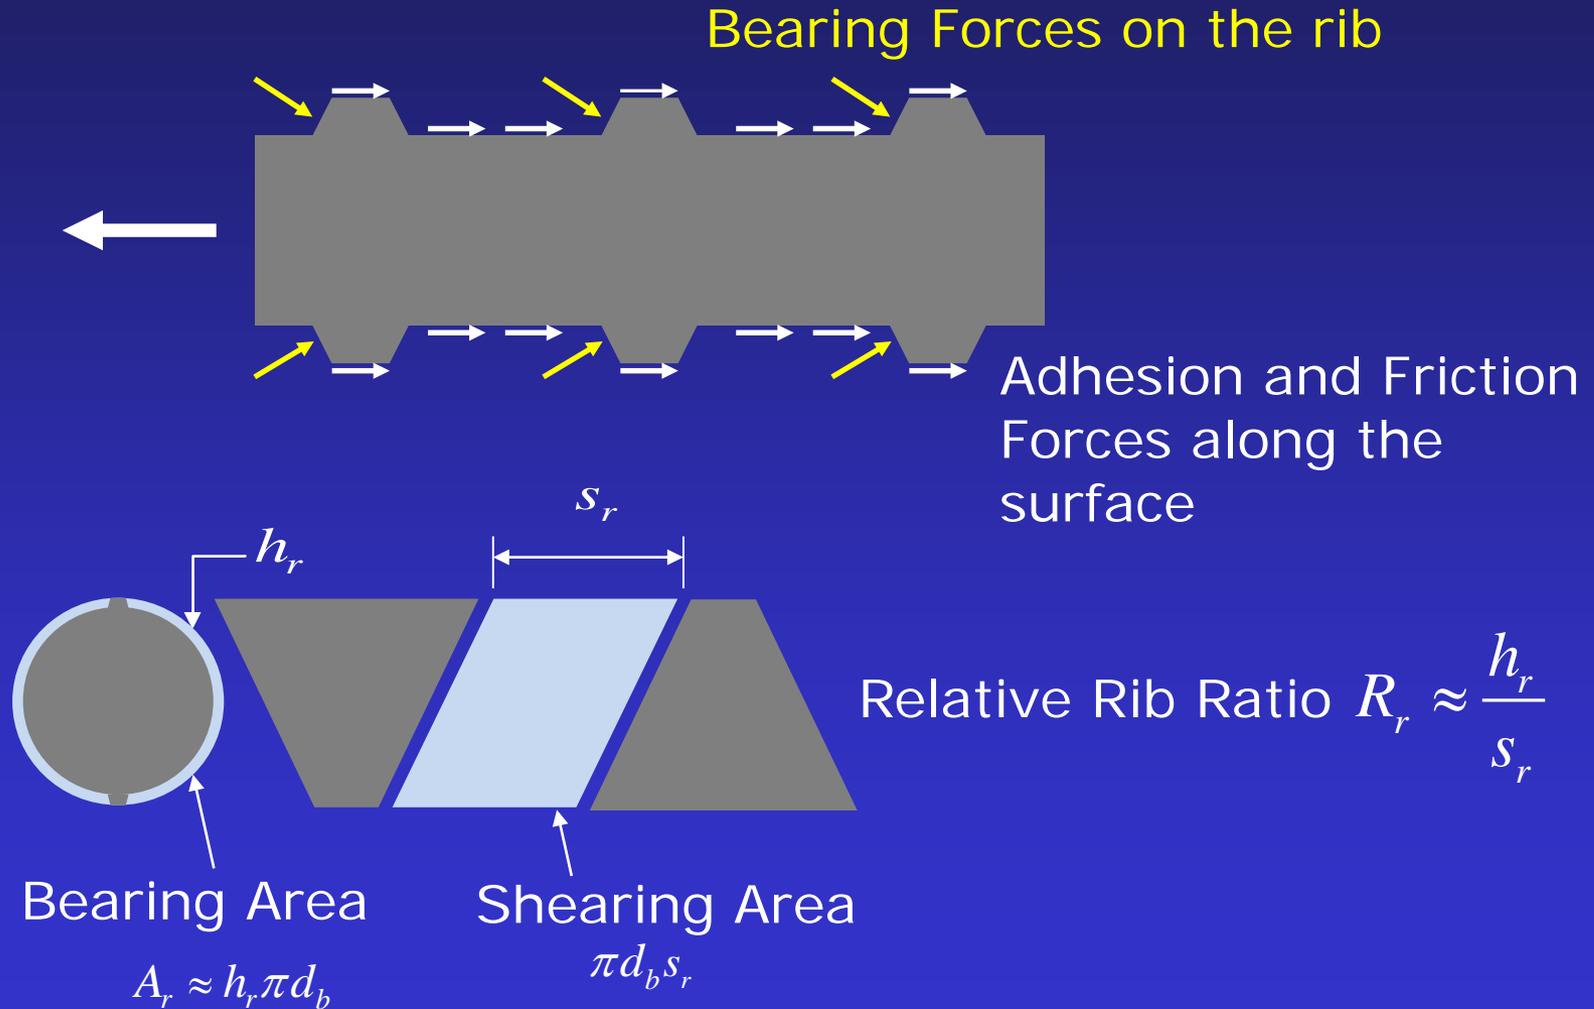
# Bond Force Transfer Mechanism

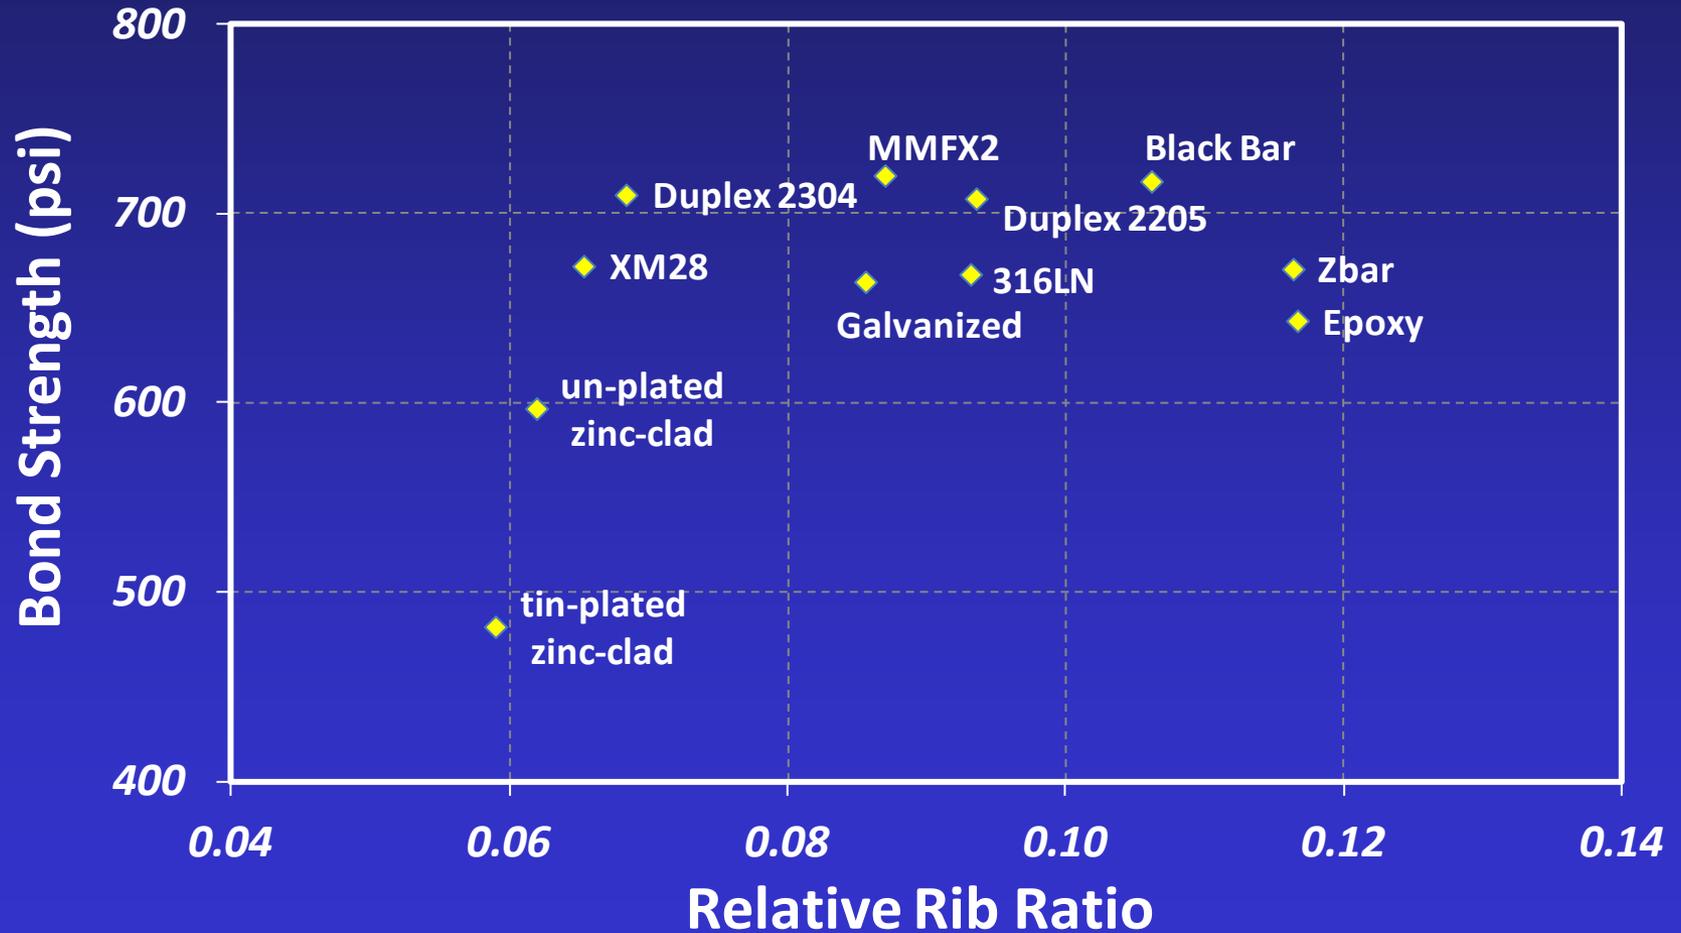
# Effect of Relative Rib Ratio

No.5 Bars
