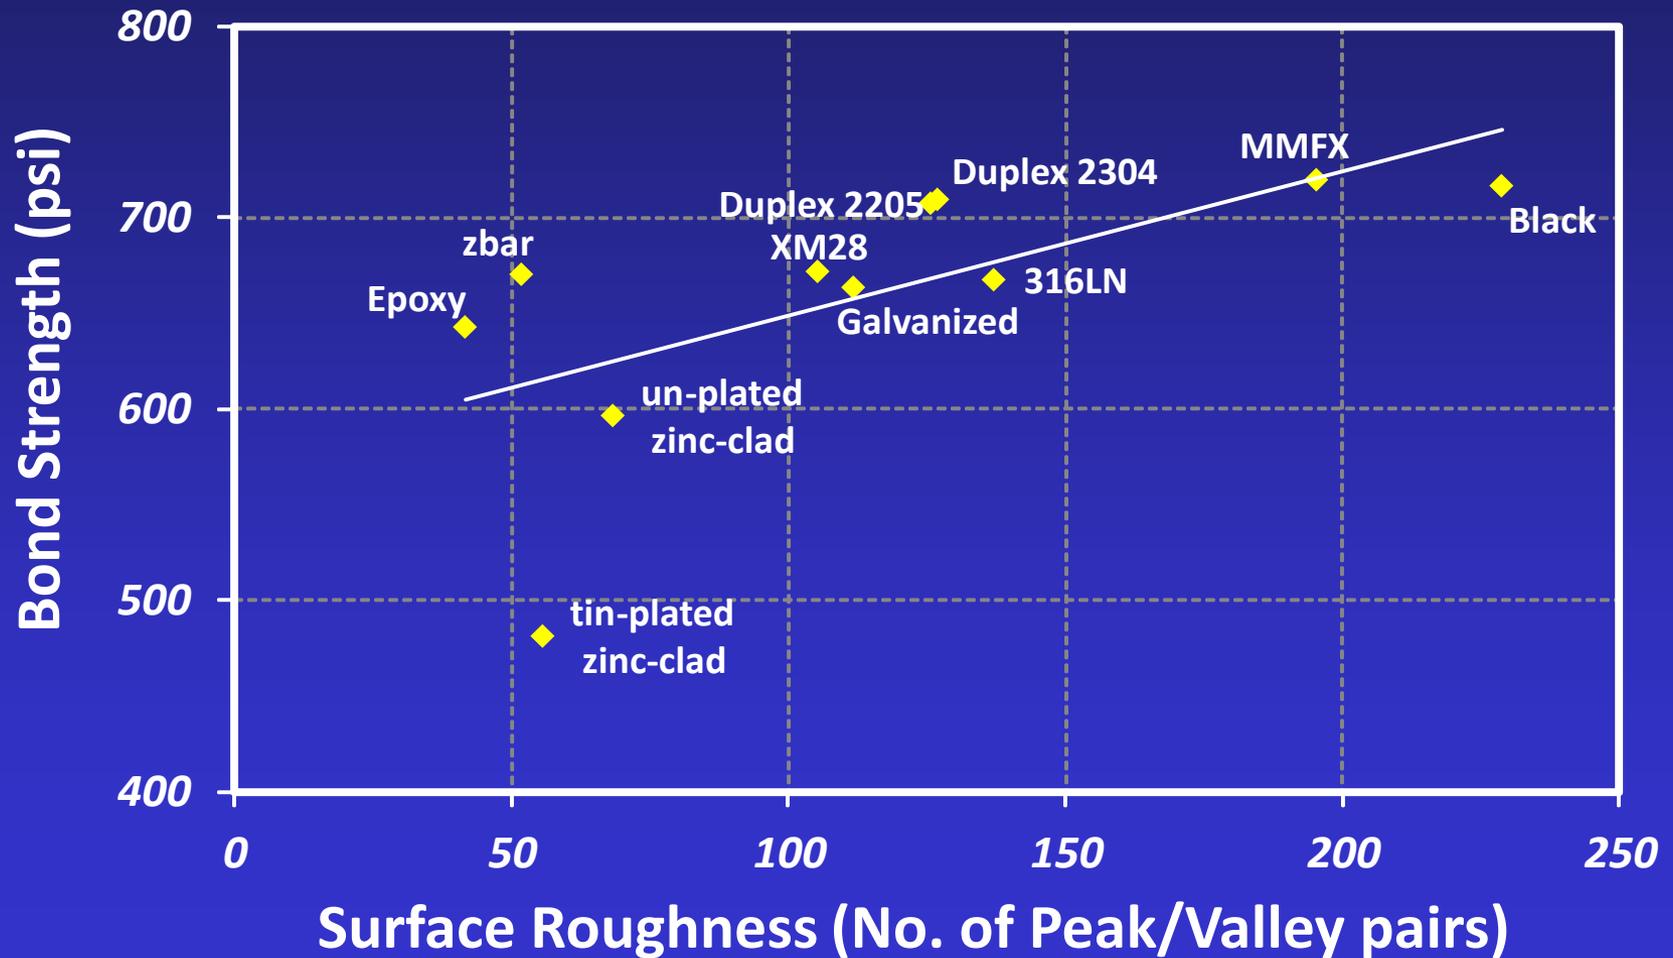
# Effect of Surface Roughness

No.5 Bars

- **Bond Ratio**
  - MMFX2, Duplex 2205, Duplex 2304, 316LN = Black
  - Black > XM28 (97%), Galvanized (96%), Zbar (94%)  
> Epoxy (89%) > Zinc-clad (79%)
- **Relative Rib Ratio**
  - Low influential to bond strength
- **Surface Roughness and Coating Thickness**
  - High correlation to bond strength

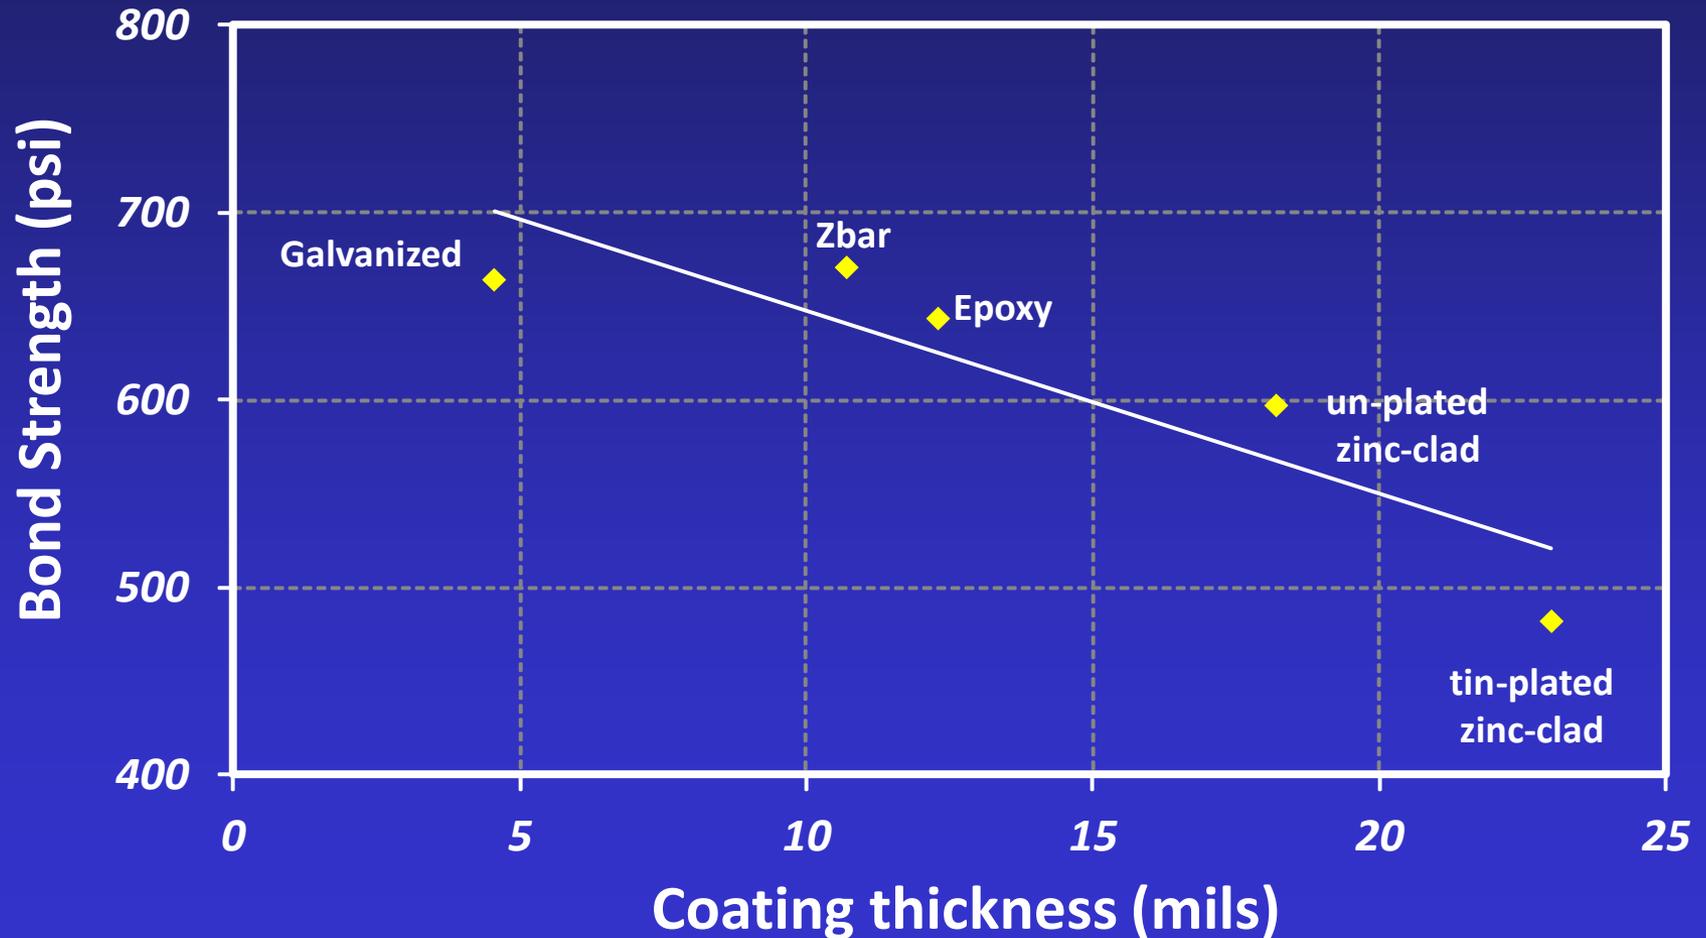
# Effect of Coating Thickness

No.5 Bars
